Emerald Green Property Owners Association

April 13, 2026 • Rock Hill, NY

FULL RESERVE STUDY

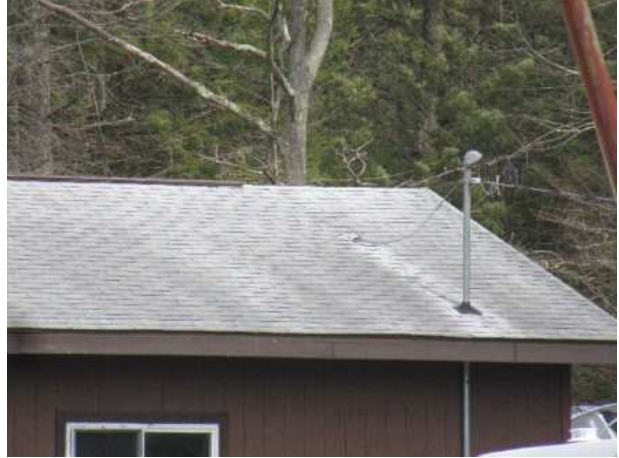
Previous replaced shingles, missing shingles and deterioration

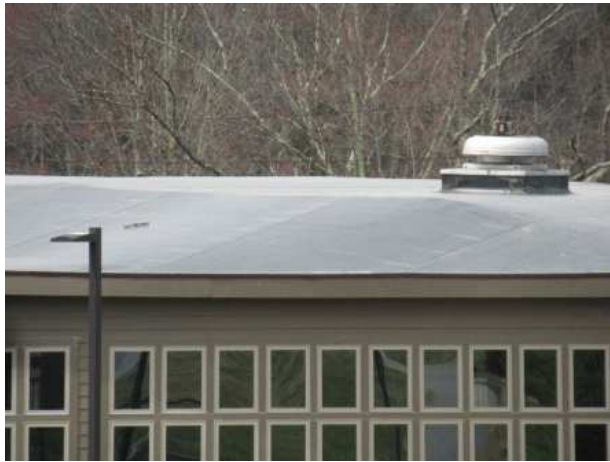
Condition: Good overall condition with no significant deterioration evident. Management and the Board do not report any leaks.

EPDM roof overview

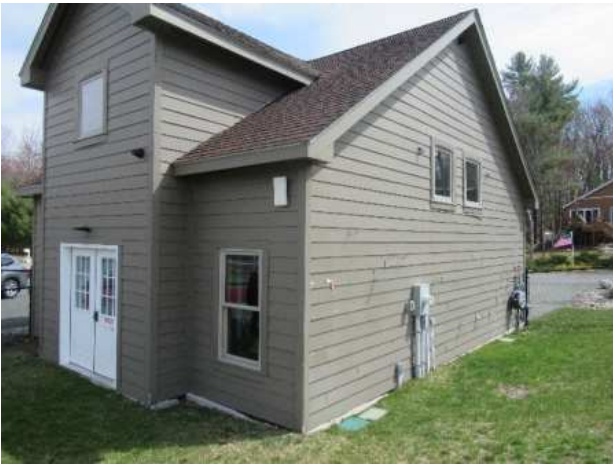
Condition: Good to fair overall condition with damage, stains, loose and missing trim, fascia and soffit, and paint finish deterioration evident.

Pool mechanical building siding overview

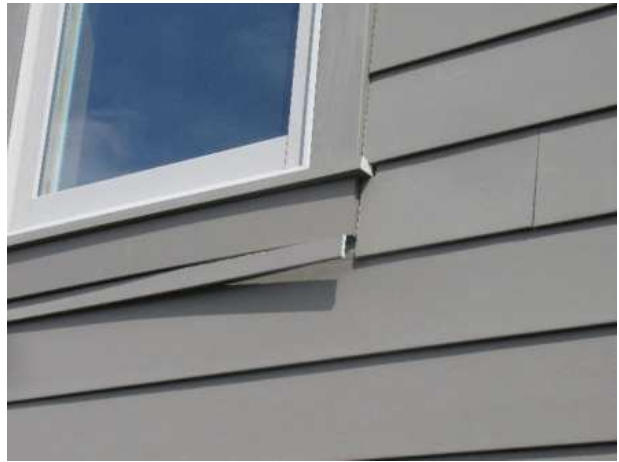
Loose trim at the pool mechanical building

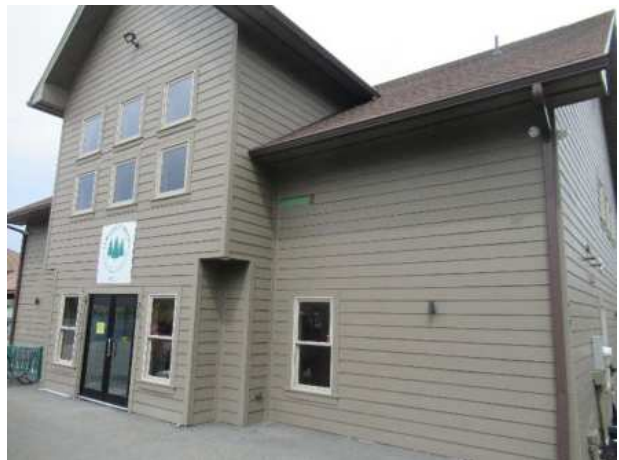
Pool house siding overview

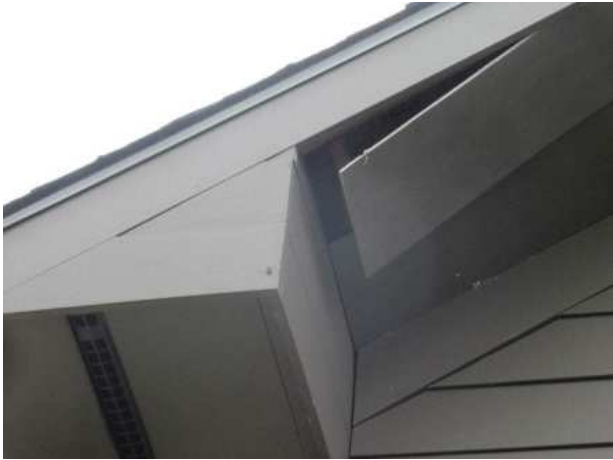
Loose soffit at the pool house

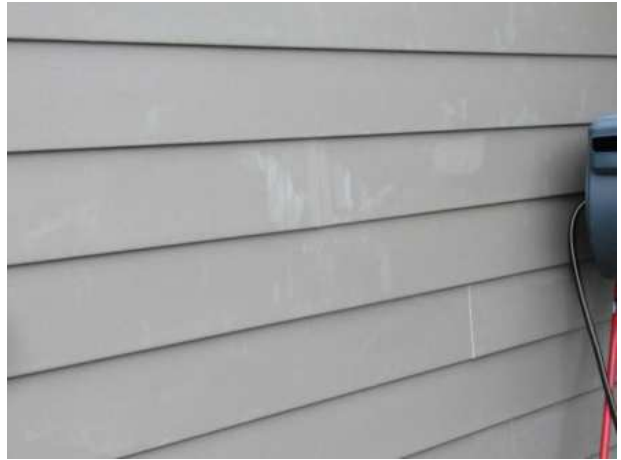
Paint finish deterioration at the pool house

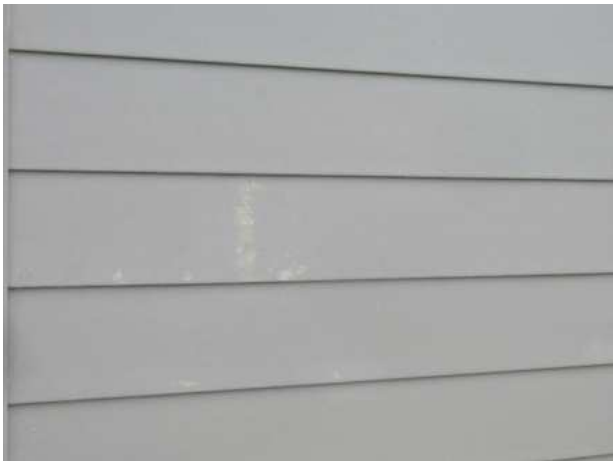
Paint finish deterioration at the pool house

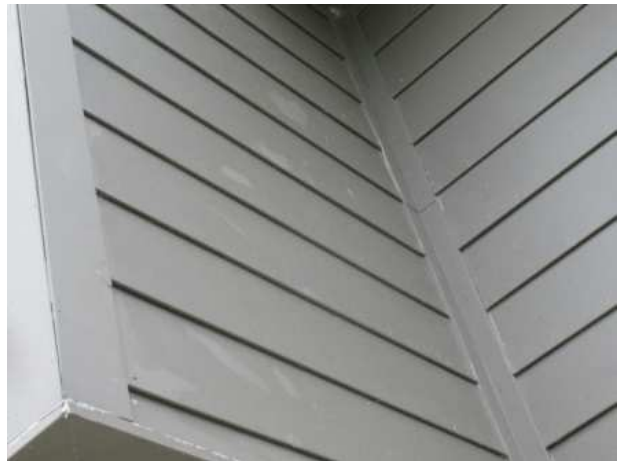
Paint finish deterioration at the pool house

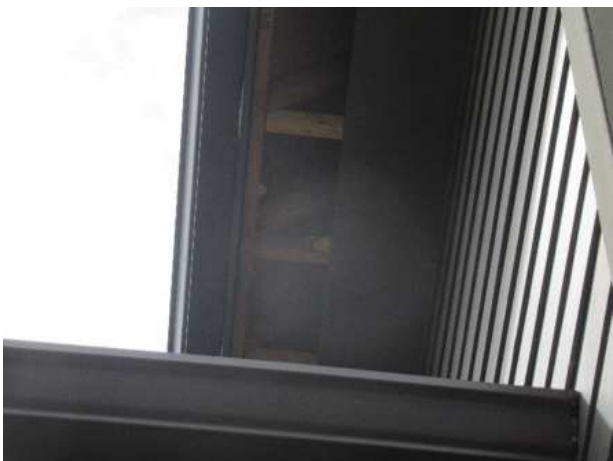
Missing soffit at the pool house

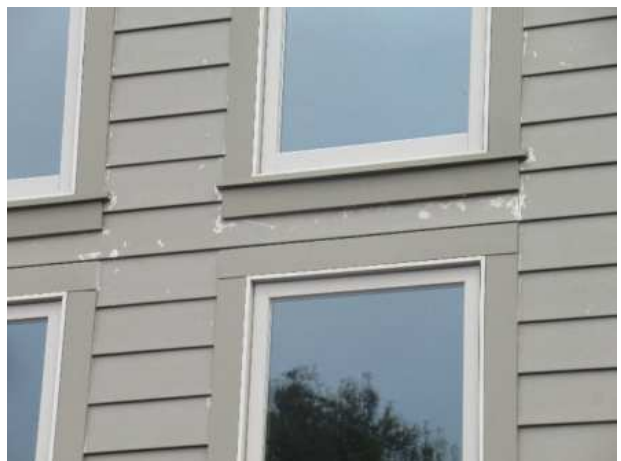
Paint finish deterioration at the pool house

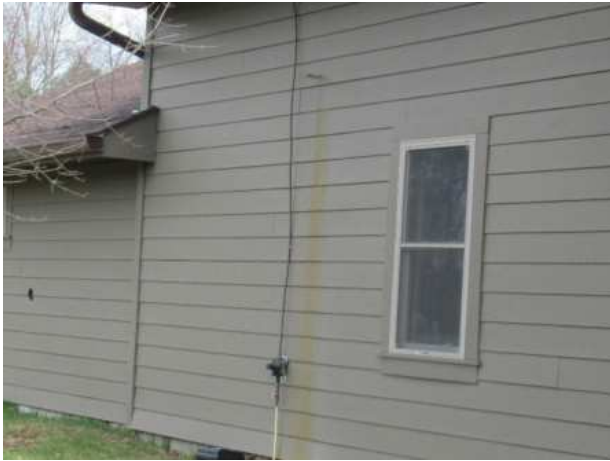
Stains at the clubhouse

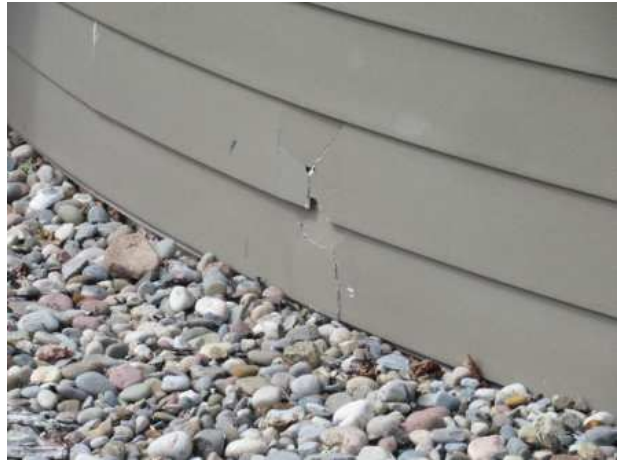
Damage at the clubhouse

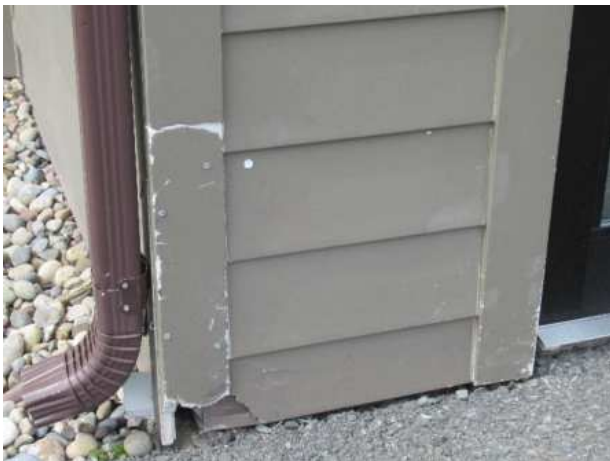
Damaged siding and trim at the clubhouse

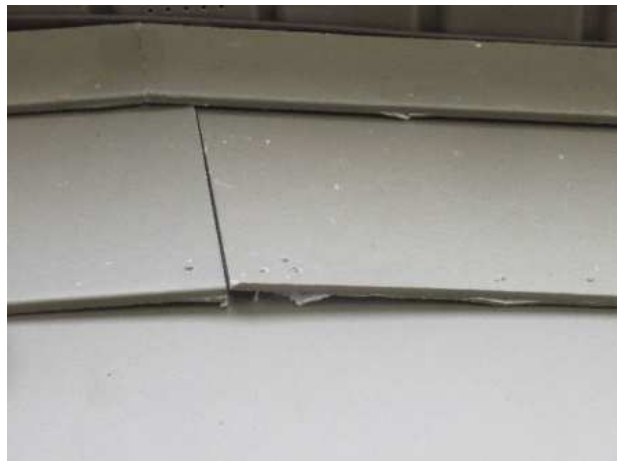
Loose siding at the clubhouse

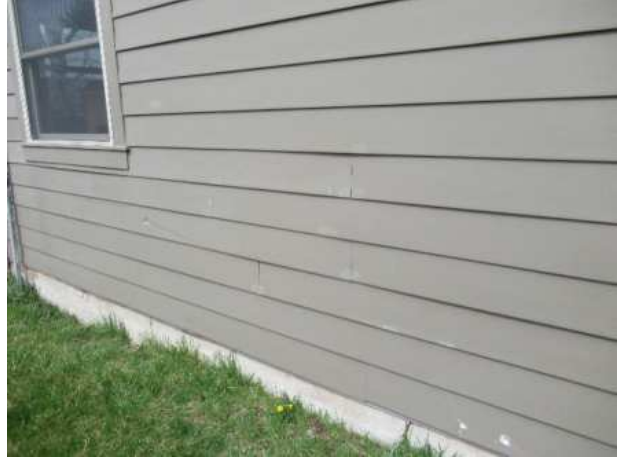
Paint finish deterioration at the clubhouse

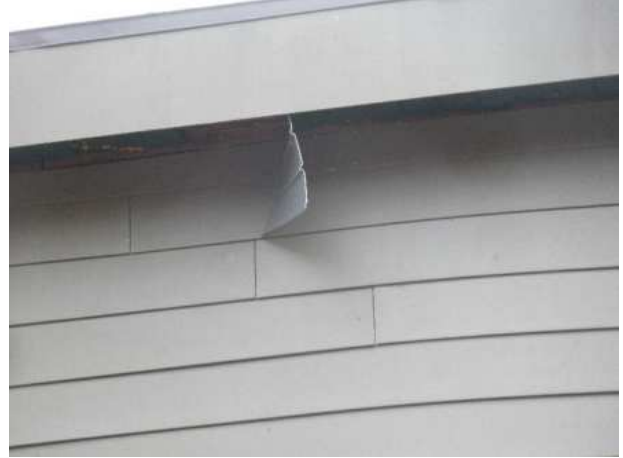
Loose trim at the entertainium building

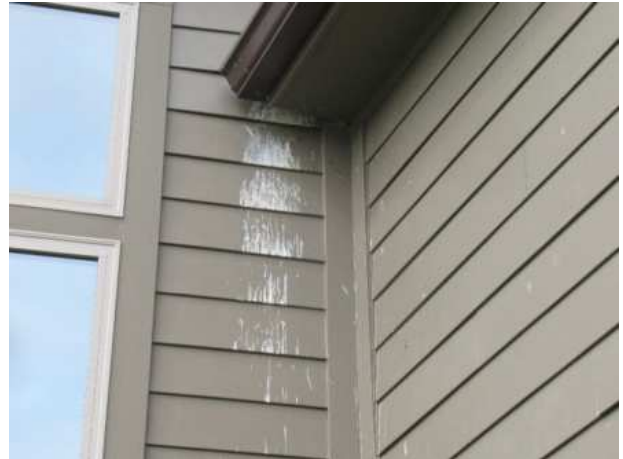
Stains at the entertainium building

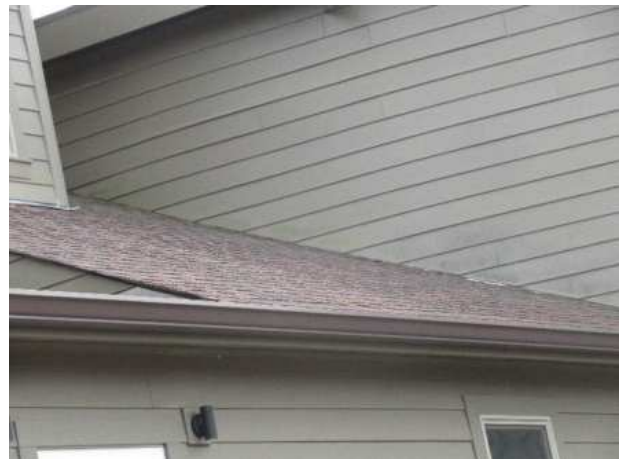
Stains at the entertainium building

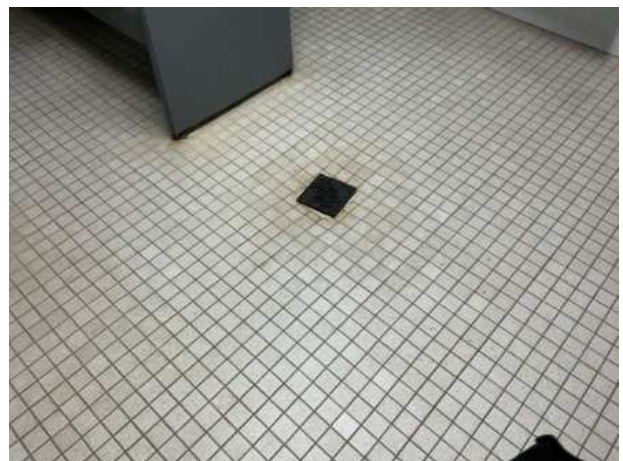
Stains

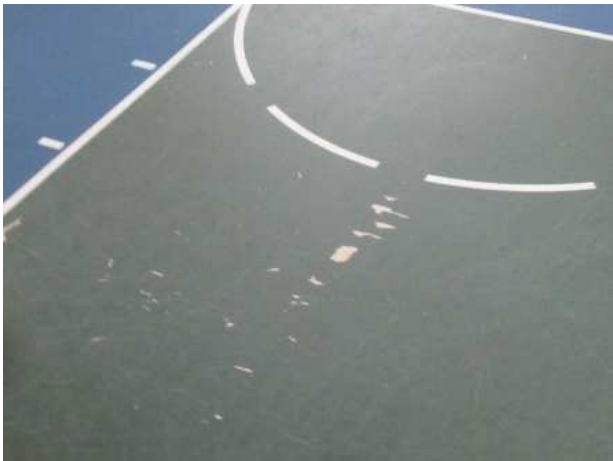
Scuffs and finish deterioration

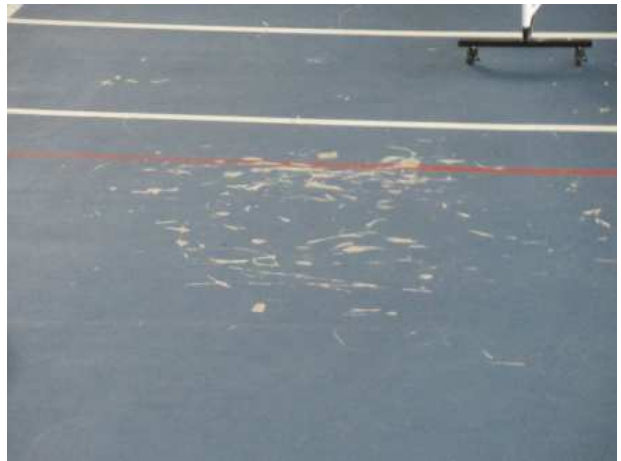
Scuffs and finish deterioration

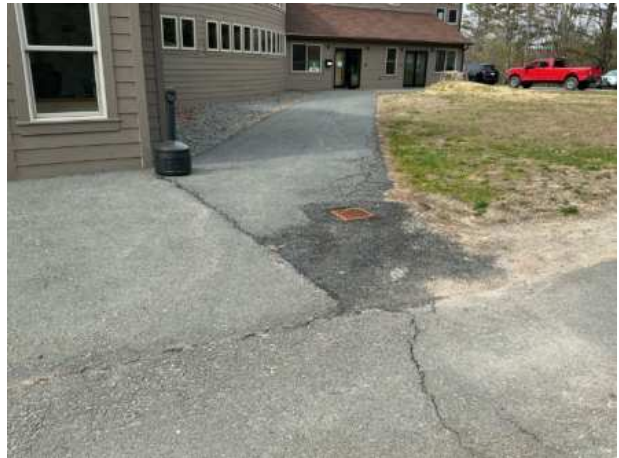
Cracks and deterioration

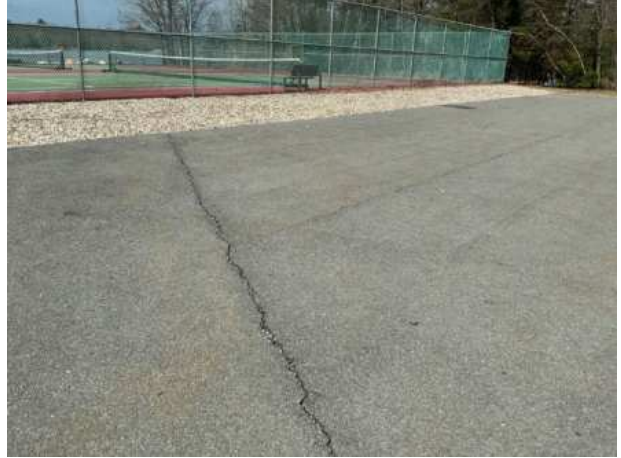
Cracks at the pool house parking area

Component Detail Notes: Proposals should include mechanically routing and filling all cracks with hot emulsion. Repairs should also include patching at areas exhibiting settlement, potholes, or excessive cracking.

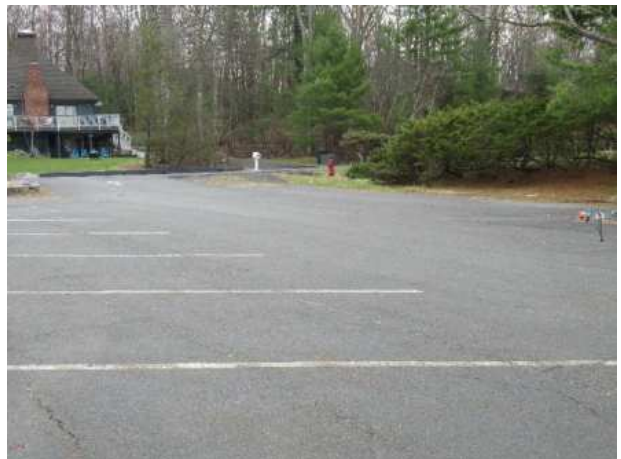
Cracks at the pool house parking area

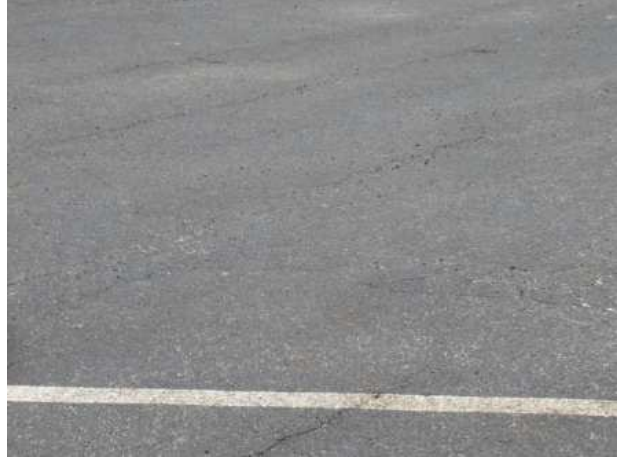
Cracks at the pool house parking area

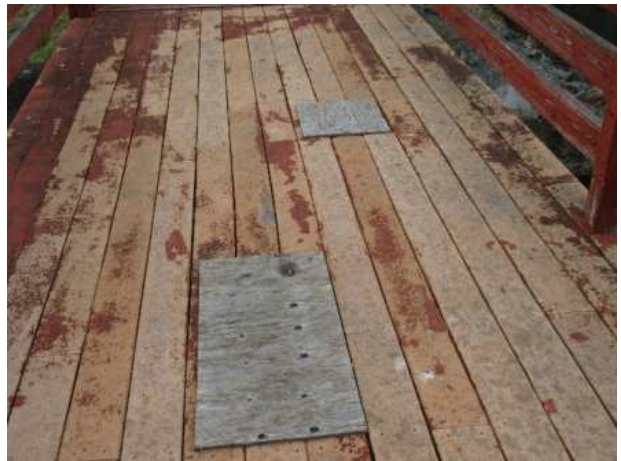
Partial repairs

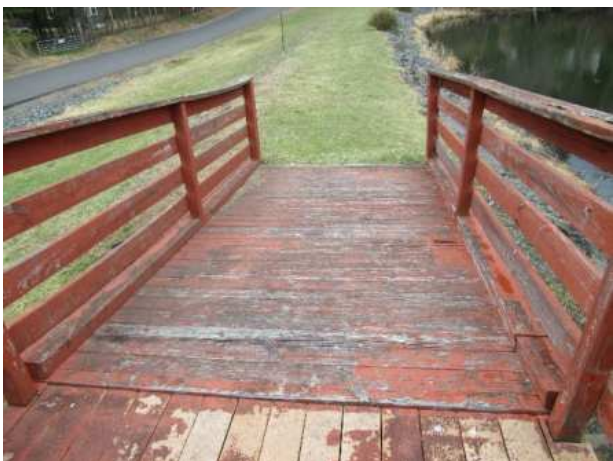
Finish deterioration

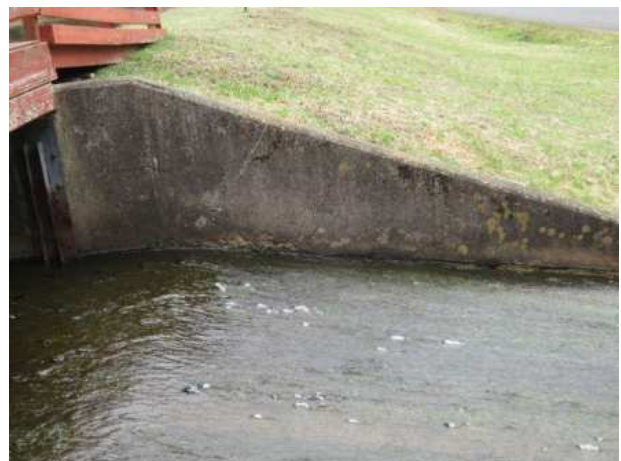
Concrete spillway at Lake Davies Note concrete deterioration and cracks

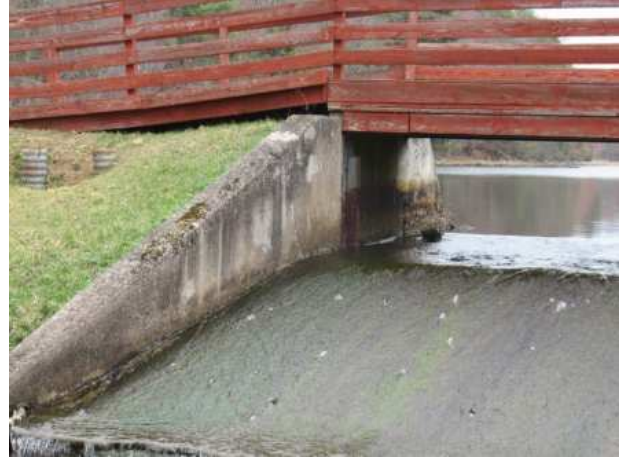
Concrete spillway at Lake Davies – Note concrete deterioration

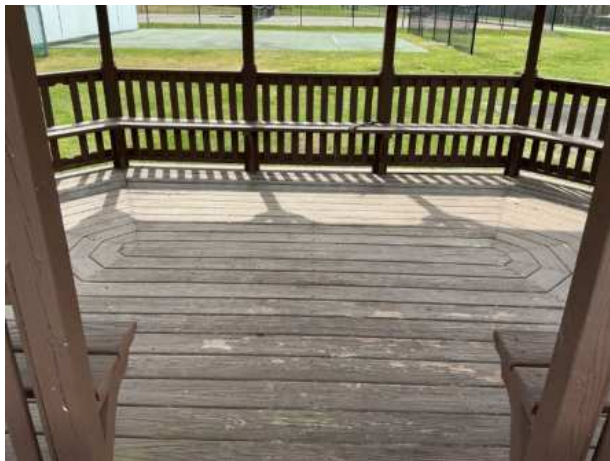
Wood deck boards – note deterioration

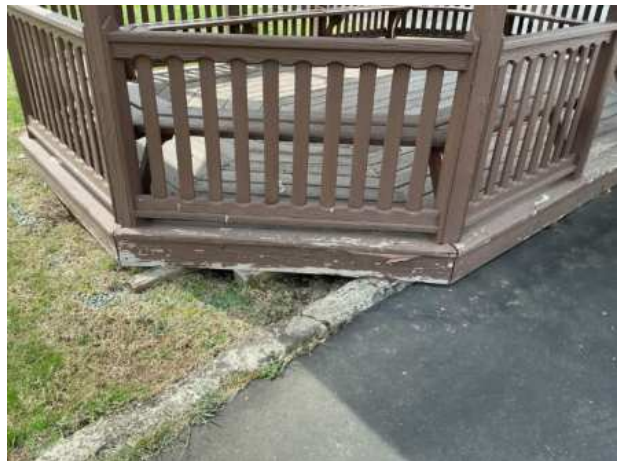
Finish deterioration

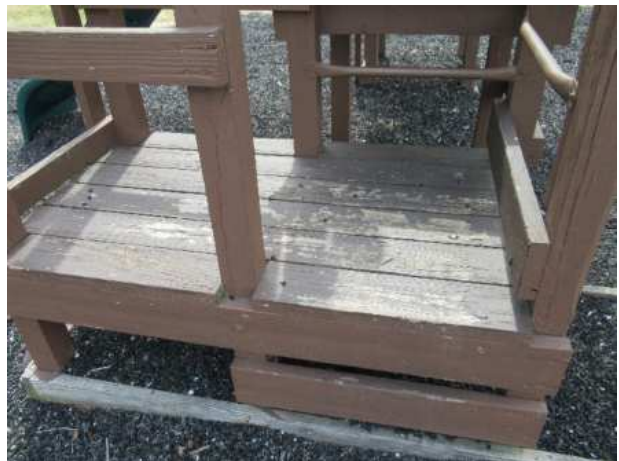
Condition: The playground at the pool house is in good overall condition and the playground near the clubhouse is in fair overall condition with rusted chains, weathered wood and deterioration evident.

Weathered wood components

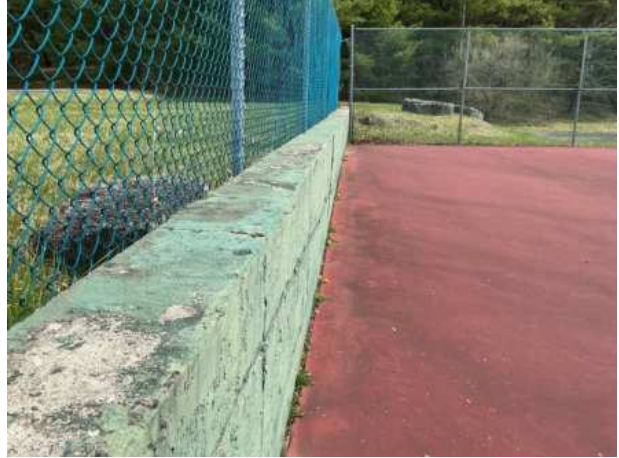
Leaning section and deterioration

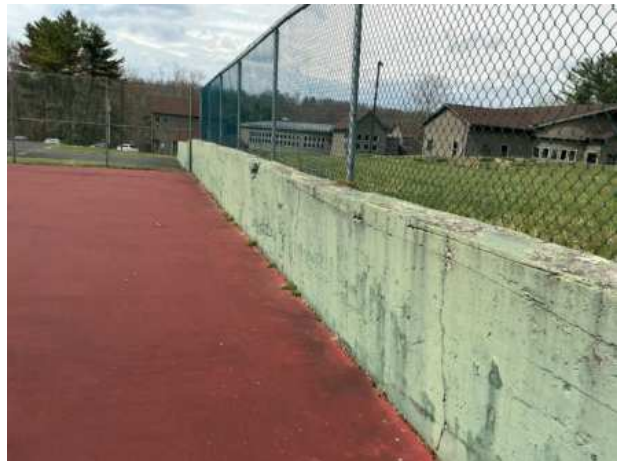
Cracks and deterioration

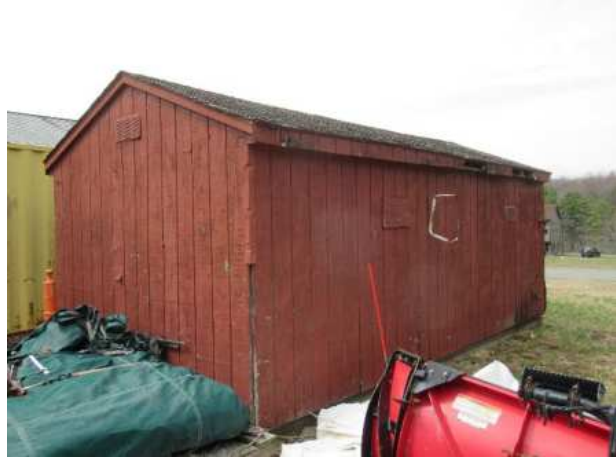
Condition: Fair to poor overall condition with damage, warps, paint finish deterioration and missing wood trim evident.

Wood damage and deterioration

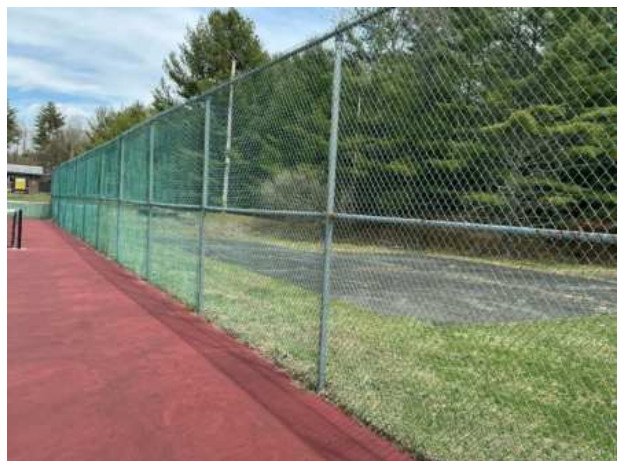
Tennis court fence at the clubhouse – Note warped webbing

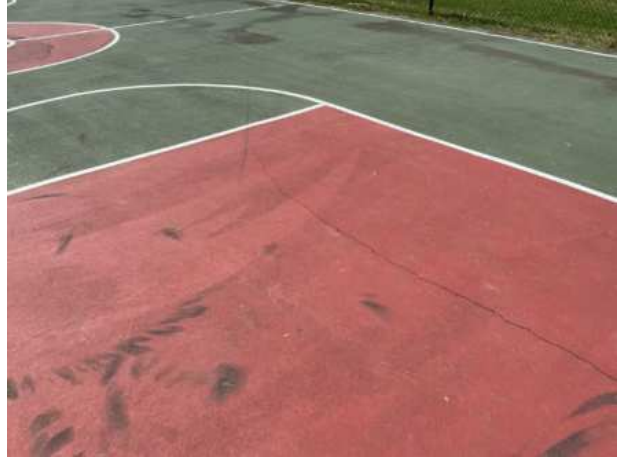
Cracks at the basketball court

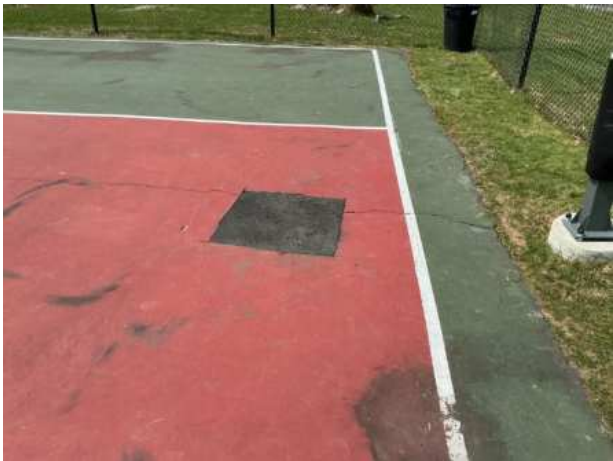
Patch repair and cracks at the basketball court

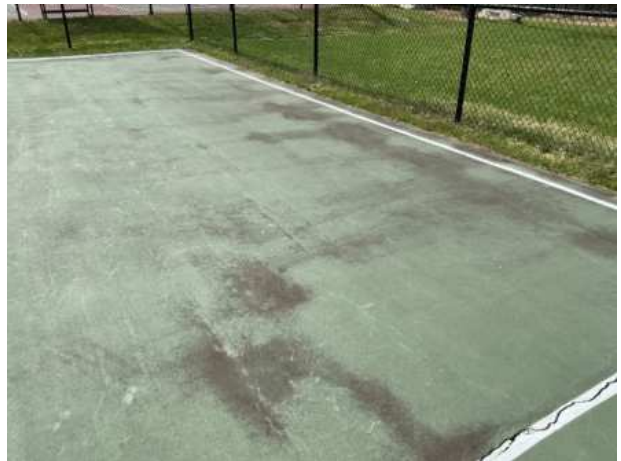
Stains at the basketball court

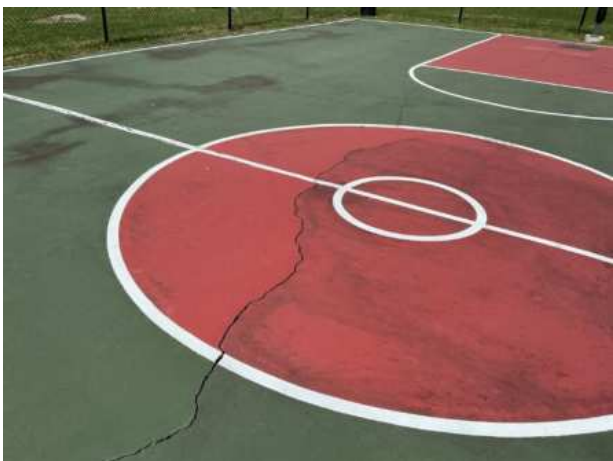
Stains and cracks at the basketball court

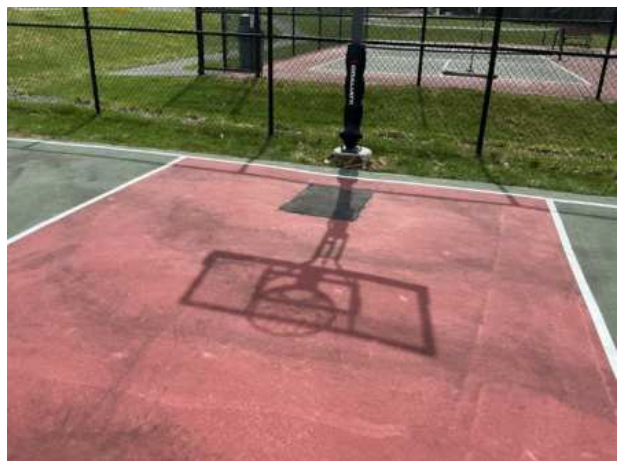
Stains and color coat deterioration at the basketball court

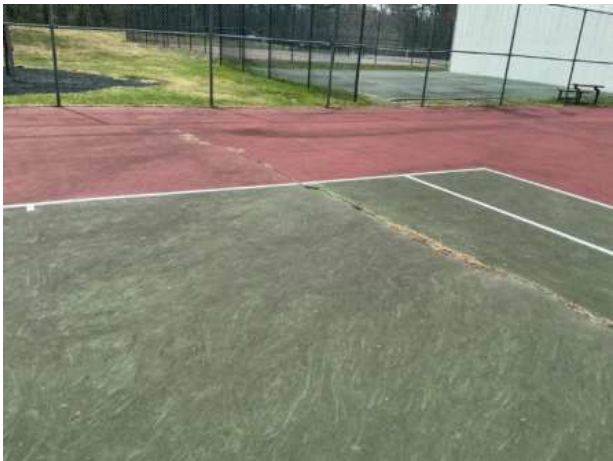
Cracks at the Tennis court at the clubhouse

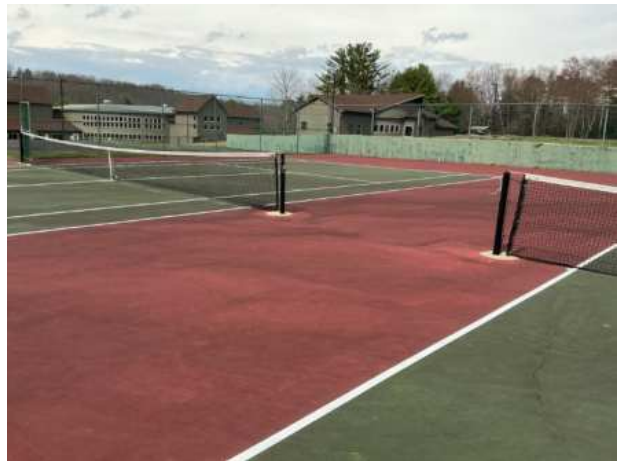
Stains at the Tennis court at the clubhouse

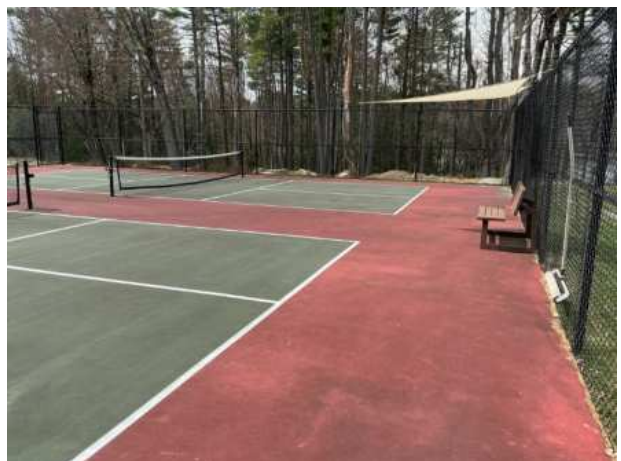
Stains at the pickleball court

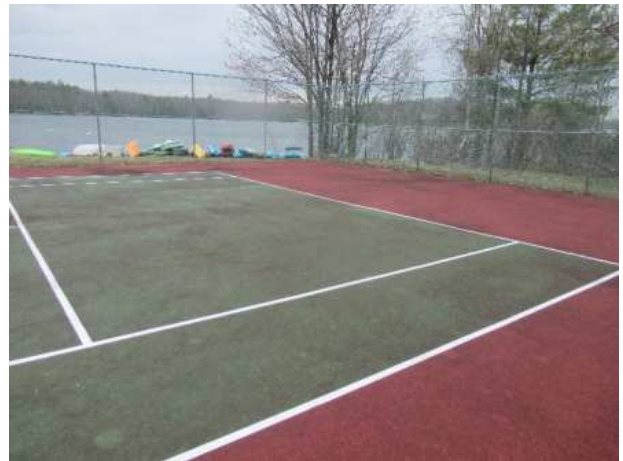
Stains at the tennis court at the pool house

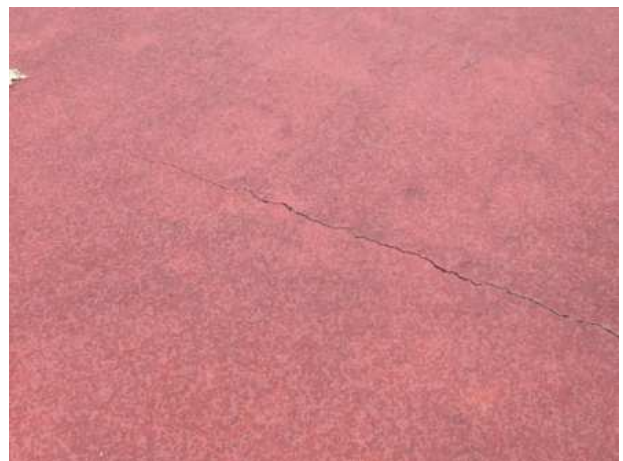
Cracks at the tennis court at the pool house

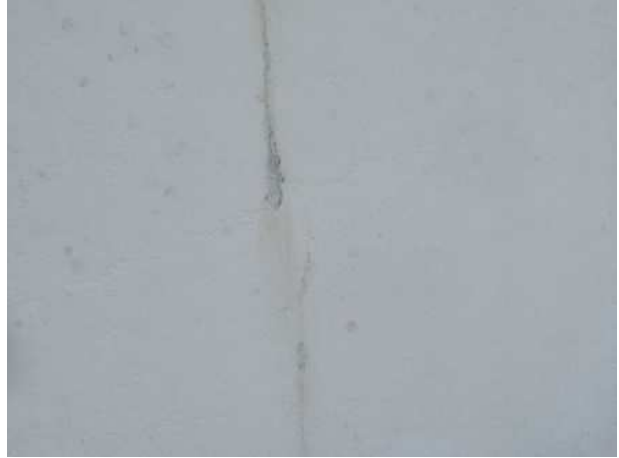
Condition: Fair overall condition with crack, finish deterioration, stains and leaning sections evident.

Cracks and finish deterioration

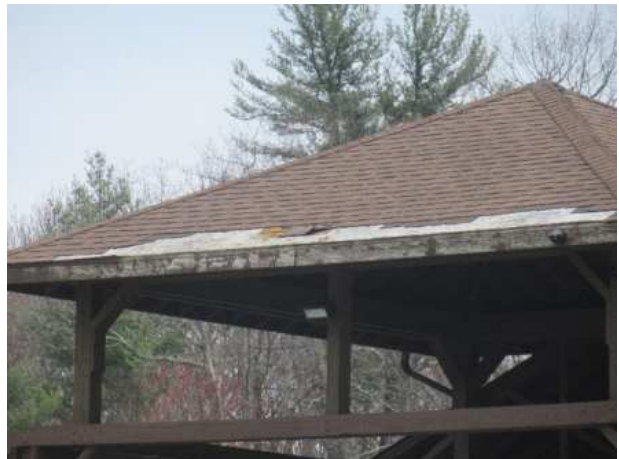
Missing shingles and deterioration

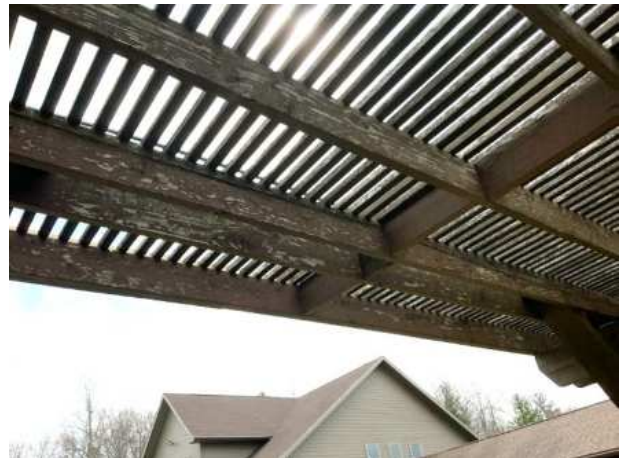
Weathered wood and finish deterioration

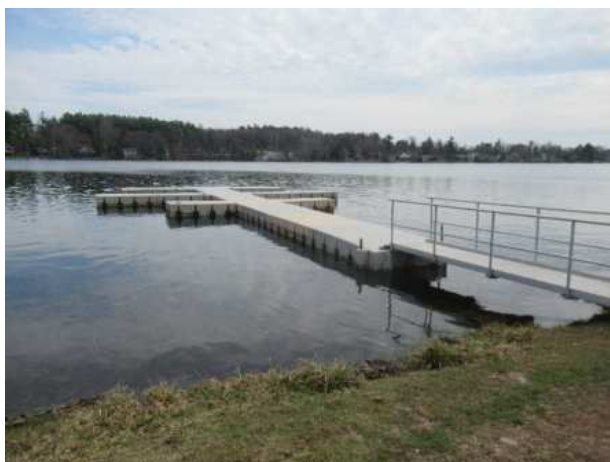
Condition: Good to fair overall condition with stains and color fade evident

Floating PVC dock overview
