Emerald Green Property Owners Association

April 13, 2026 • Rock Hill, NY

FULL RESERVE STUDY

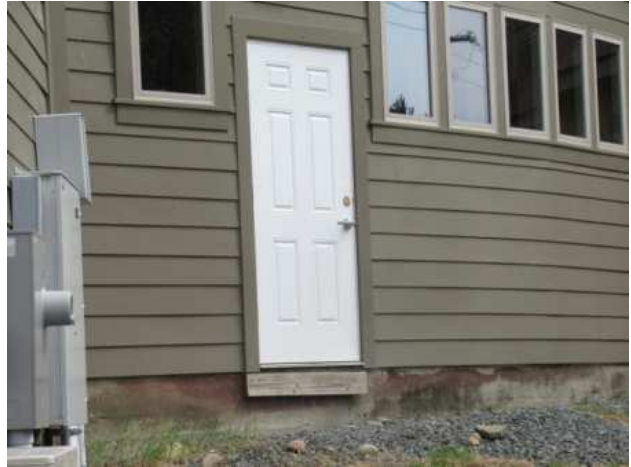
Doors - We note door exits are not at grade

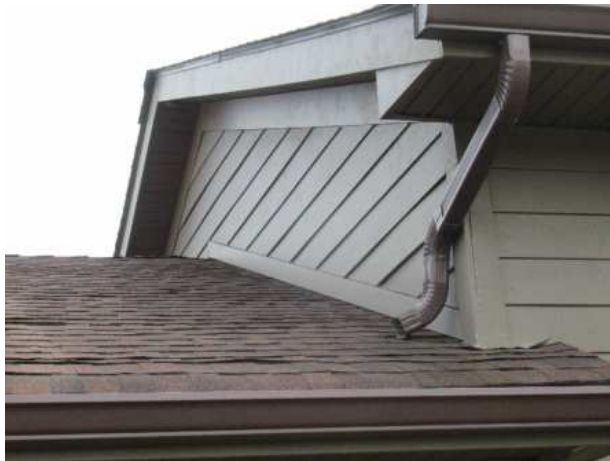
Shingle lift and downspouts discharge directly onto lower roof at the clubhouse

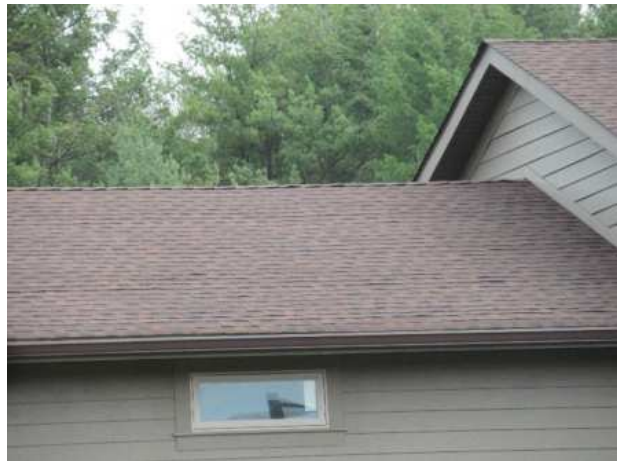
Shingle lift at the clubhouse

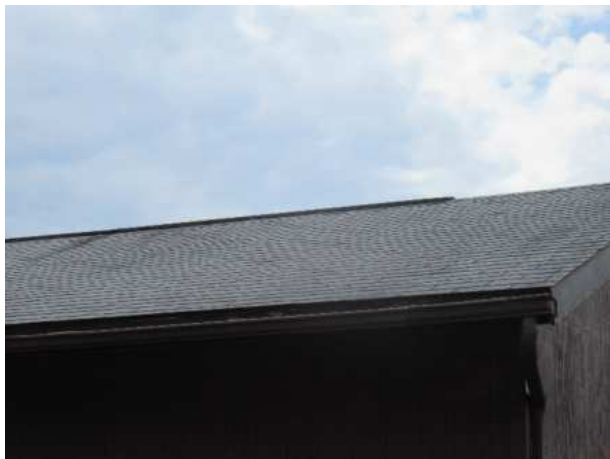
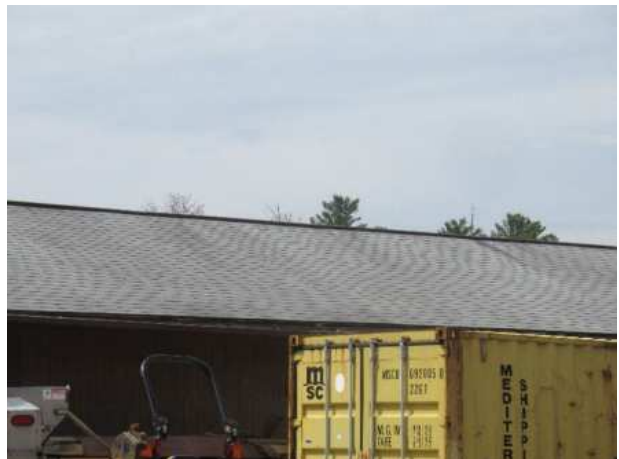
Maintenance building roof overview

Maintenance building: Approximately 15 squares, unknown age, poor overall condition with stains, missing shingles, partial replacements, weathered shingles and deterioration evident.

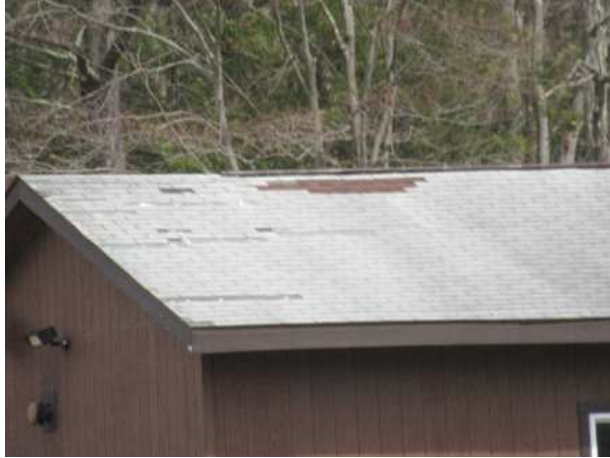
Previous replaced shingles, missing shingles and deterioration

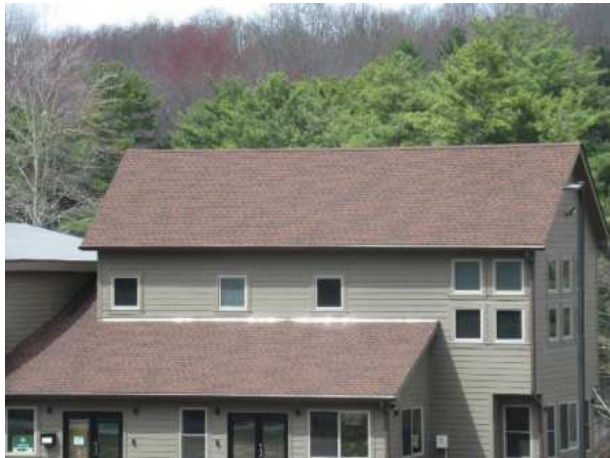
Entertainium building roof overview

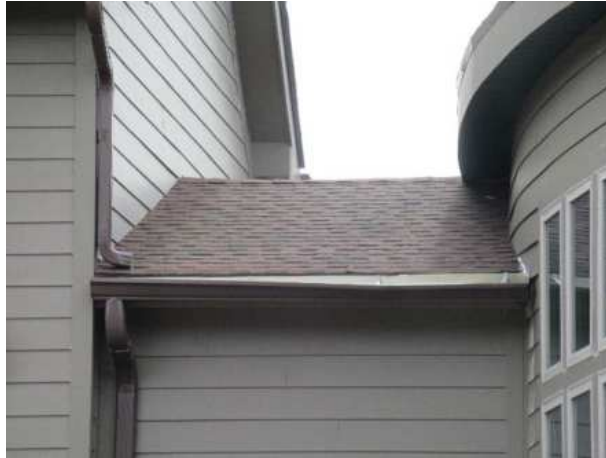
Downspouts discharge directly onto lower roof at the entertainium building

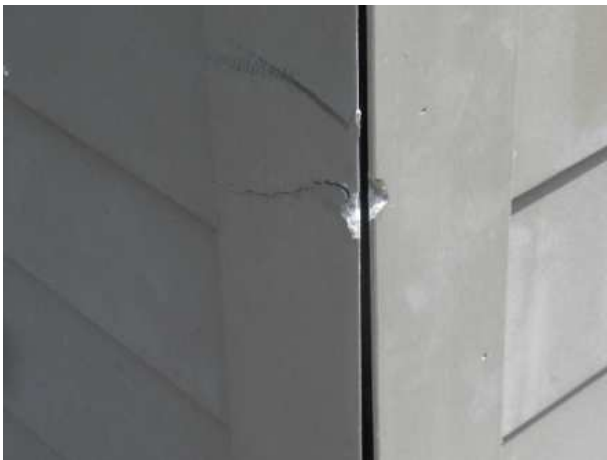
Damage at the pool mechanical building

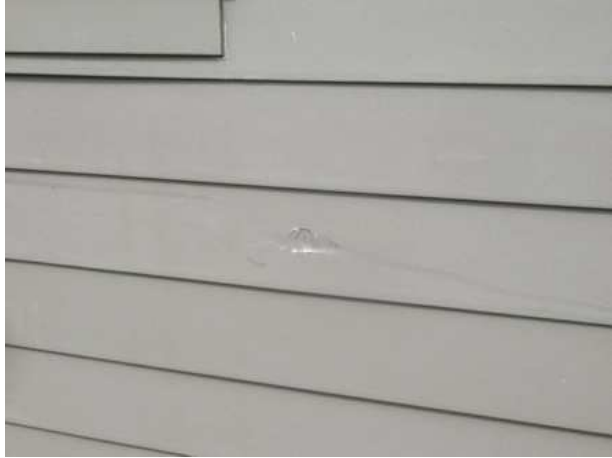
Damaged siding at the clubhouse

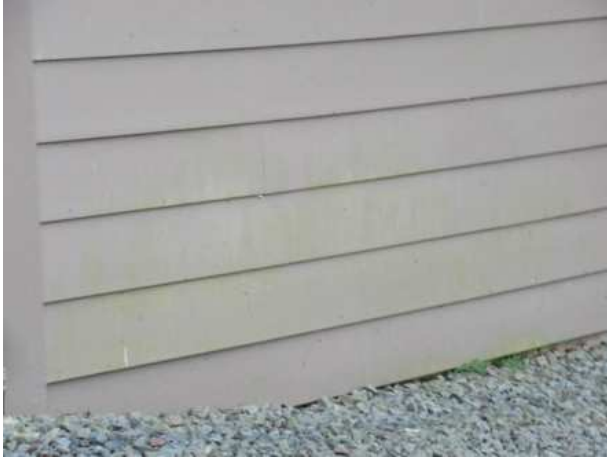
Stains at the entertainium building

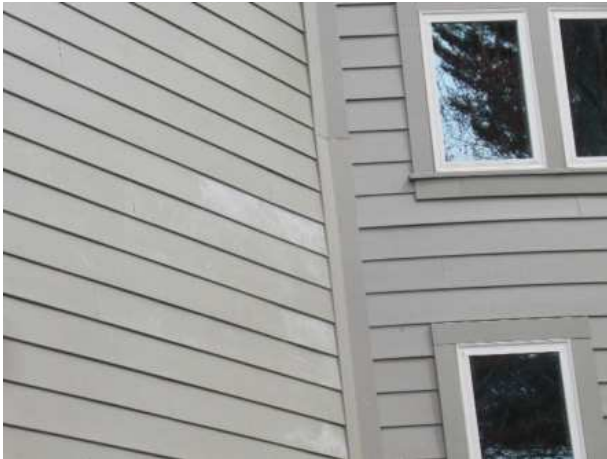
Paint finish deterioration at the entertainium building

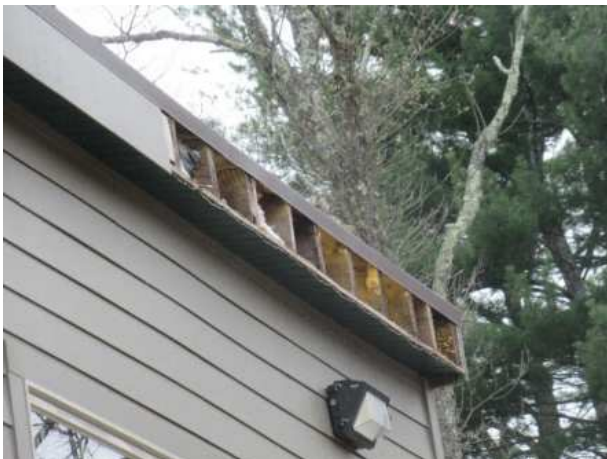
Missing fascia board at the entertainium building

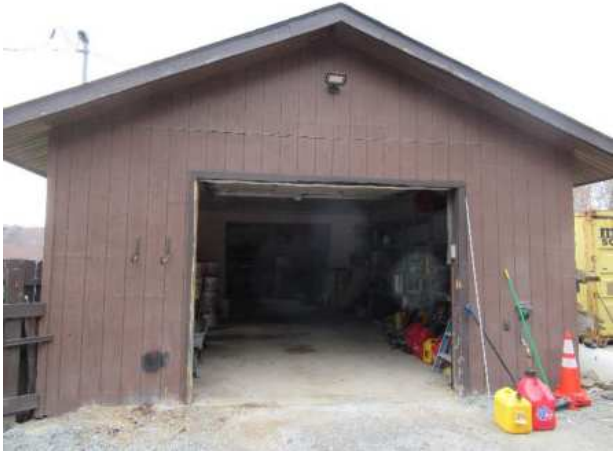
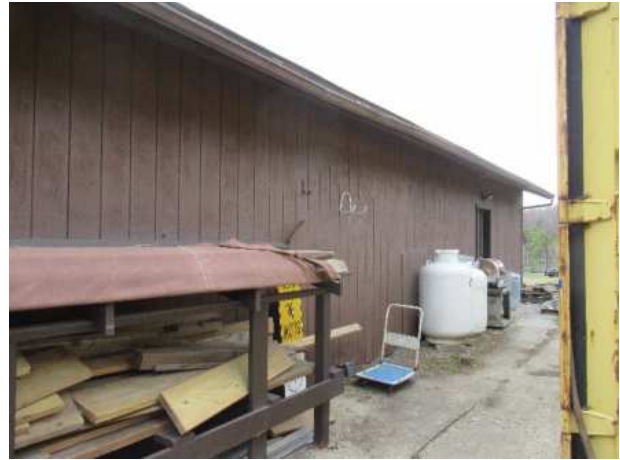
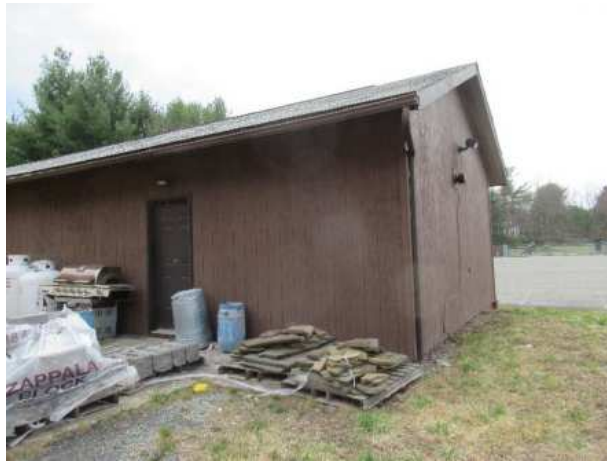
Condition: Fair overall condition with warp, deterioration and finish fade.

Wood siding at the maintenance building

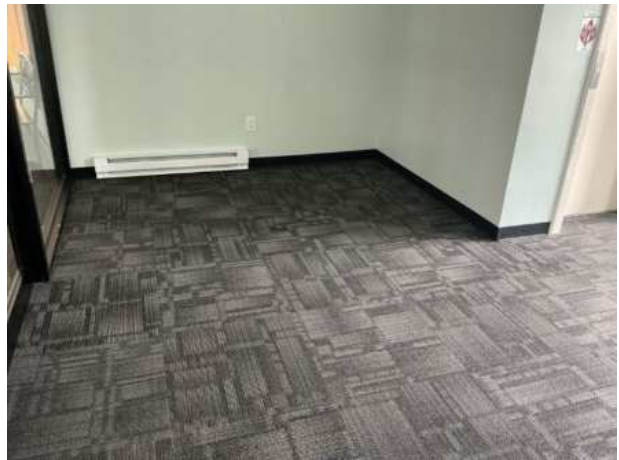
Condition: Good overall condition with no significant deterioration

Expenditure Detail Notes: Expenditure timing and costs are depicted in the **Reserve Expenditures** table in Section 3. The complete renovation should include replacement of all components listed above and the partial renovations should include the following:

- Replacement of the carpet
- Paint finish application
- Replacement of up to fifty percent (50%) of the furnishings

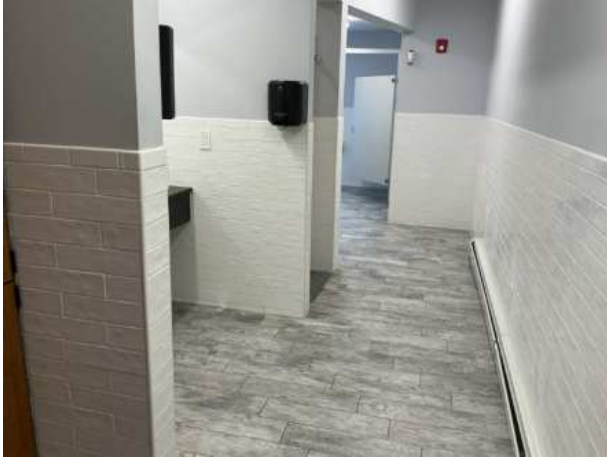
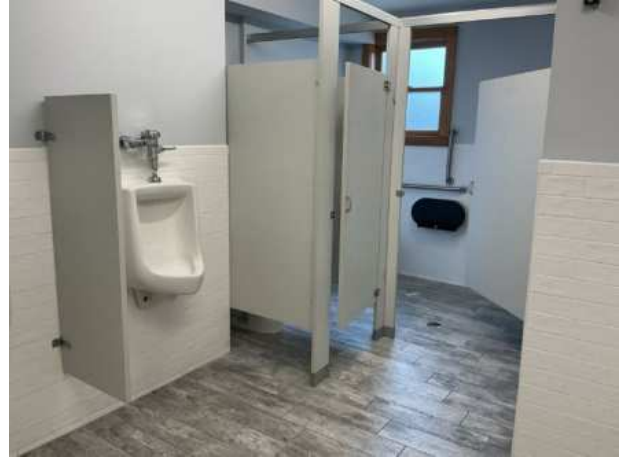
Condition: Good overall condition with no significant deterioration

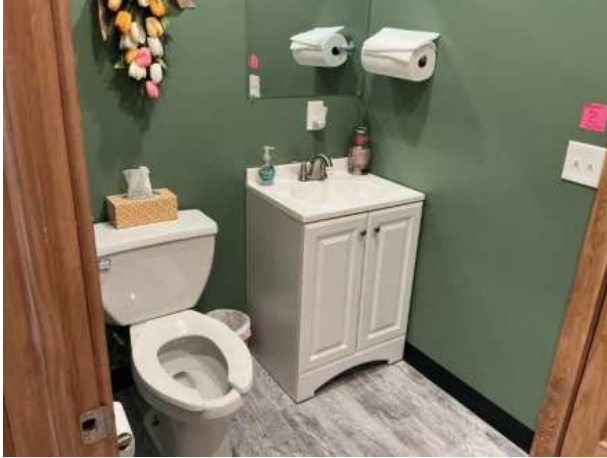
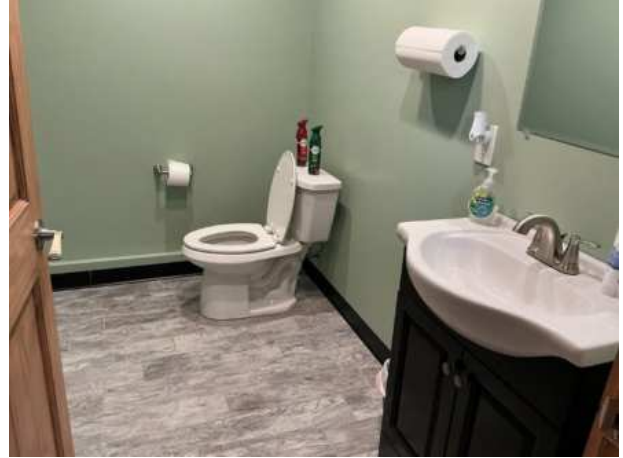
Condition: Good overall condition with no significant deterioration.

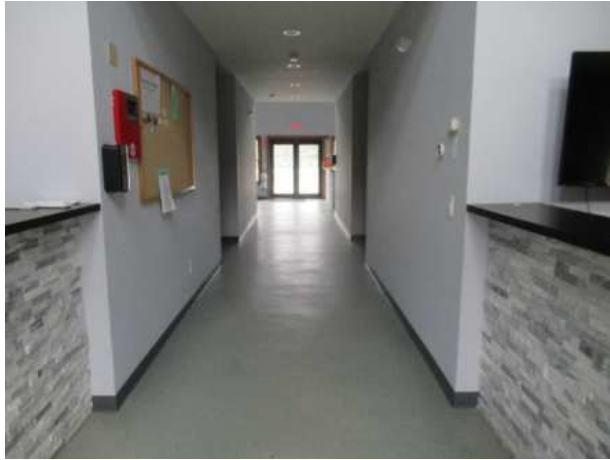
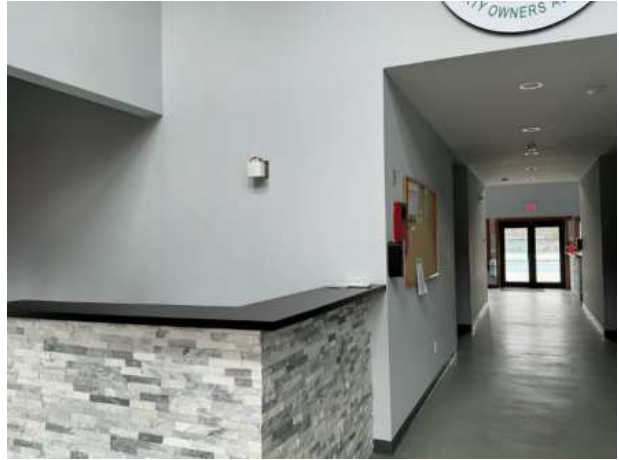
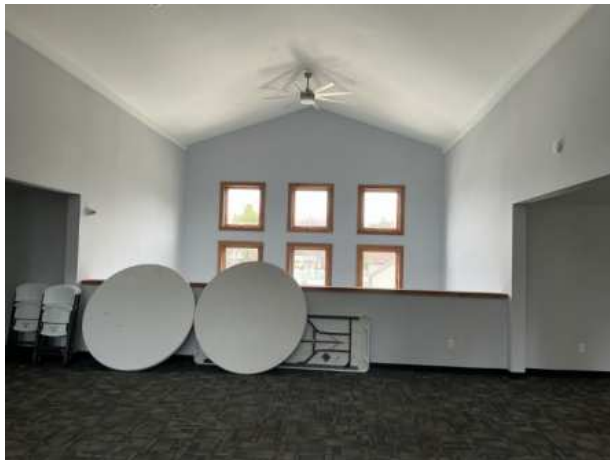
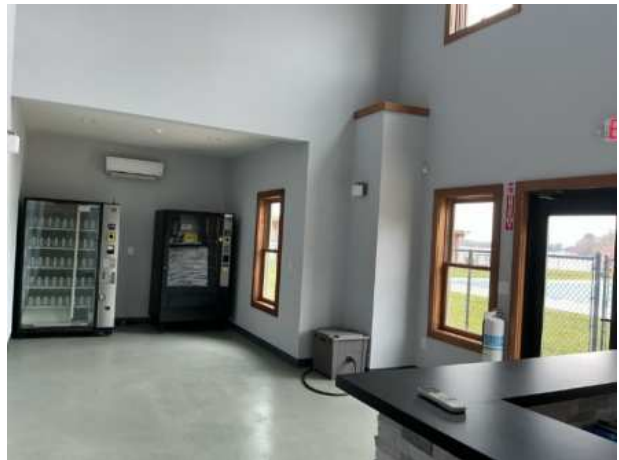
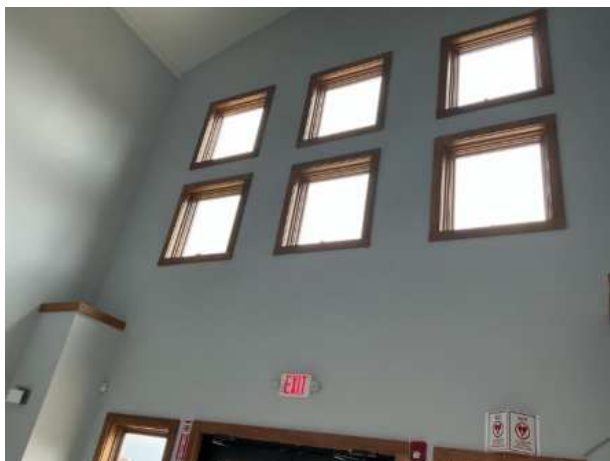
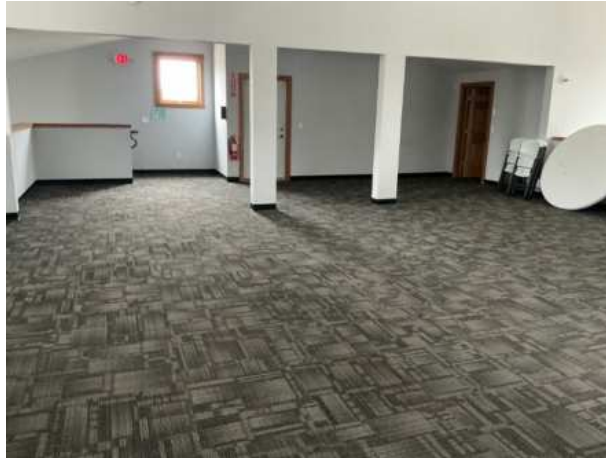
Condition: Good overall condition with no significant deterioration

Expenditure Detail Notes: Expenditure timing and costs are depicted in the **Reserve Expenditures** table in Section 3. The complete renovation should include replacement of all components listed above and the partial renovations should include the following:

- Replacement of the carpet
- Paint finishes
- Replacement of up to fifty percent (50%) of the furnishings

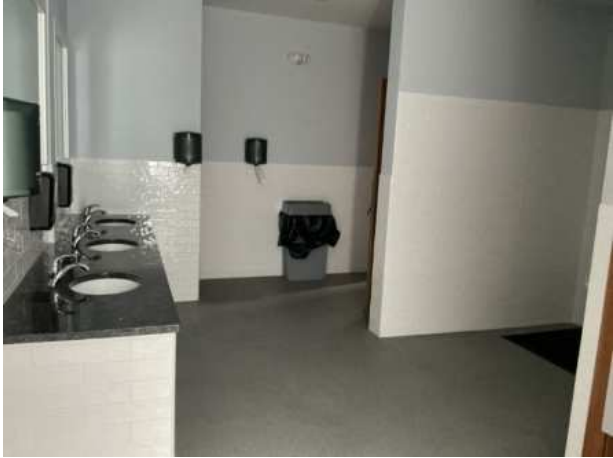
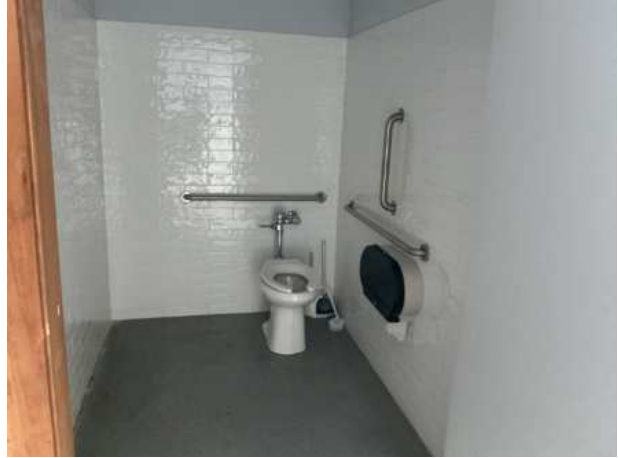
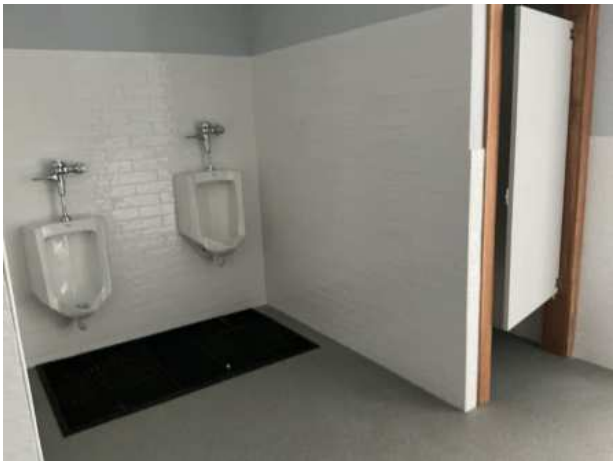
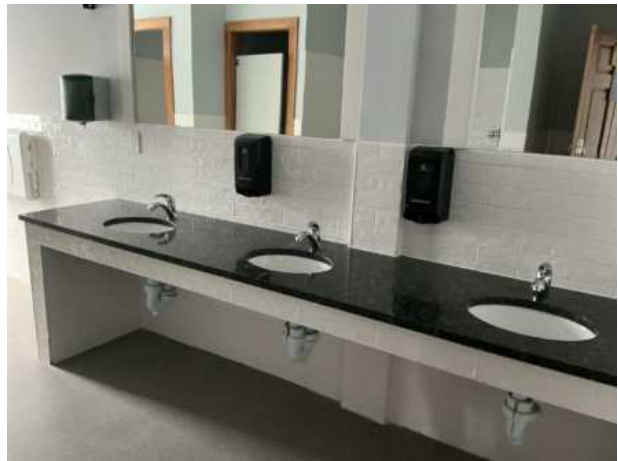
Condition: Good overall condition with no significant deterioration

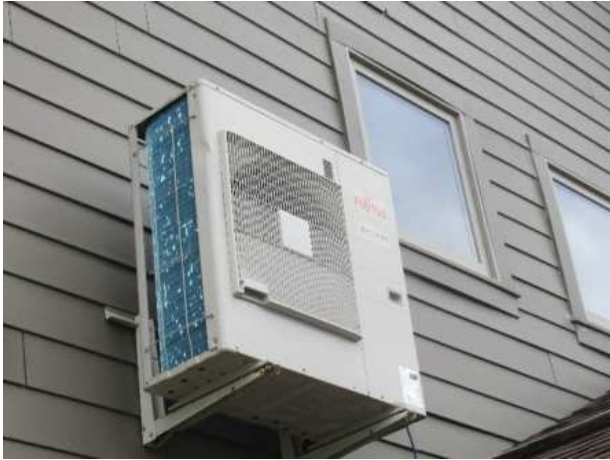
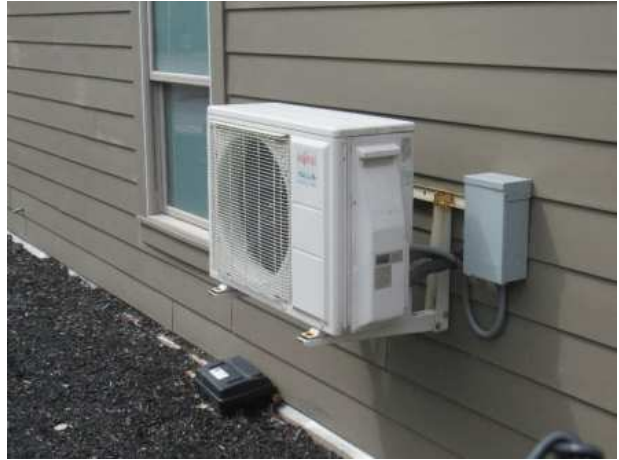
Pool house, Mini-Split Systems: 4 mini-split systems, dates to 2021, reported satisfactory without operational deficiencies.

Mini-split condensing units at the pool house

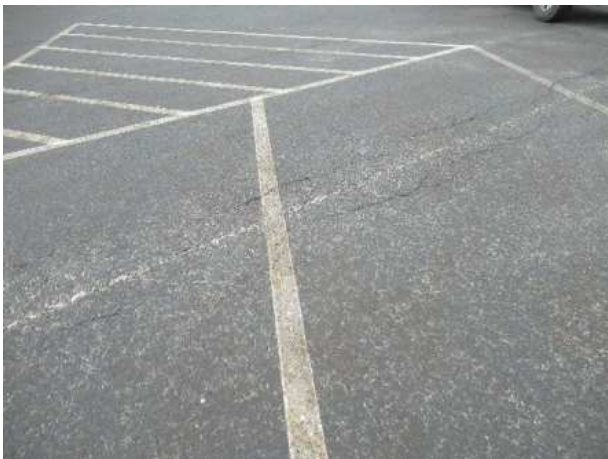
Cracks at the pool house parking area

Component Detail Notes: Proposals should include mechanically routing and filling all cracks with hot emulsion. Repairs should also include patching at areas exhibiting settlement, potholes, or excessive cracking.

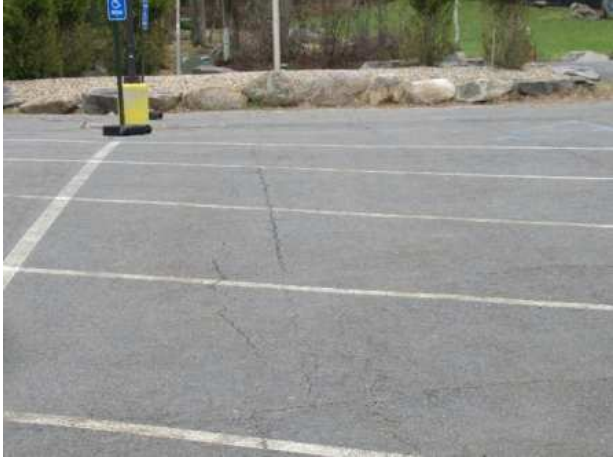
Cracks at the pool house parking area

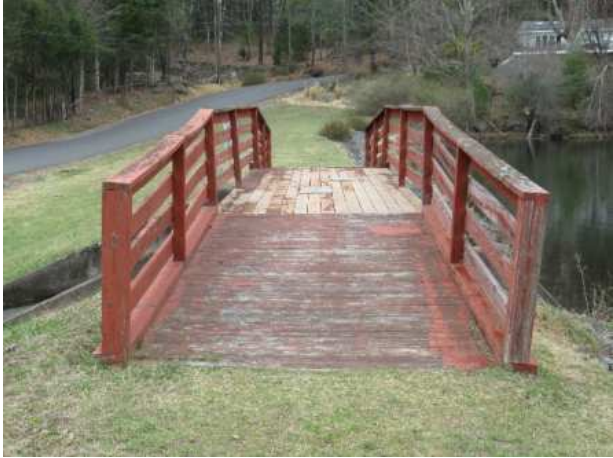
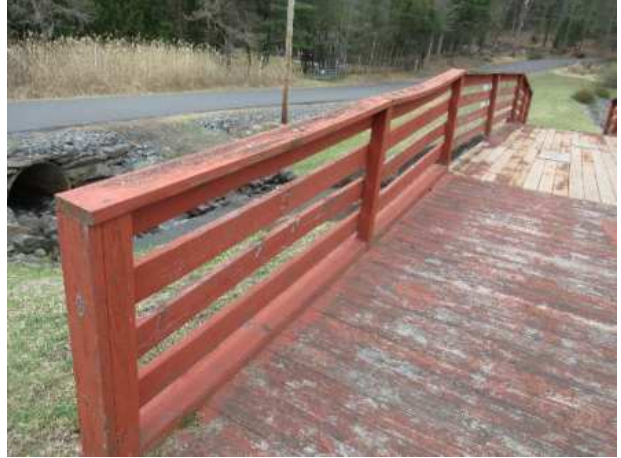
Condition: Poor overall condition with weathered wood, finish deterioration, rust at the metal framing, partial repairs and warps evident.

Expenditure Detail Notes: Expenditure timing and costs are depicted in the **Reserve Expenditures** table in Section 3. We recommend the Association budget for paint applications and repairs through the operating budget.

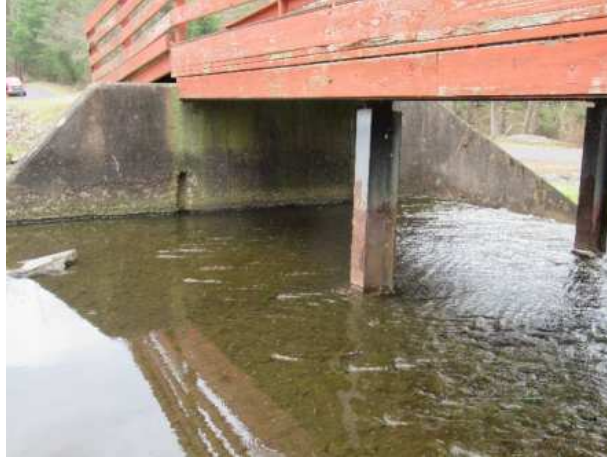
Rust at the metal columns

- Annually:
 - Inspect to identify and correct any unsafe conditions
 - Secure loose fasteners and replace deteriorated fasteners
 - Replace deteriorated wood components
 - Check railing stability and fasteners
- Every three years:
 - Power wash with algaecide and application of sealer/stain if applicable

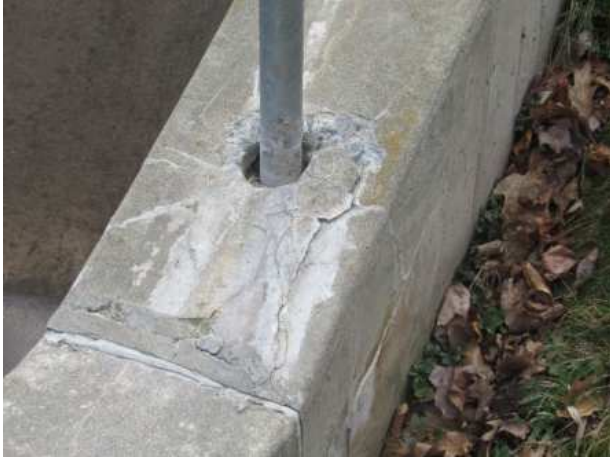
Condition: The dam and spill way on Lake Louise Marie is reported in satisfactory condition. During our inspection we did observe areas of deterioration to the concrete at the bases of the railings. The Lake Davies dam and spillway are reported to be in unsatisfactory condition, with observed weeping and damp areas along the landscaped side of the embankment that may indicate seepage and drainage deficiencies. The Association is currently soliciting proposals for corrective repairs and plans to complete the work in 2026. Due to the non-invasive nature of our inspection, we rely on known conditions, historic information and inspections to recommend future reserve projects.

Cracked concrete at the railings

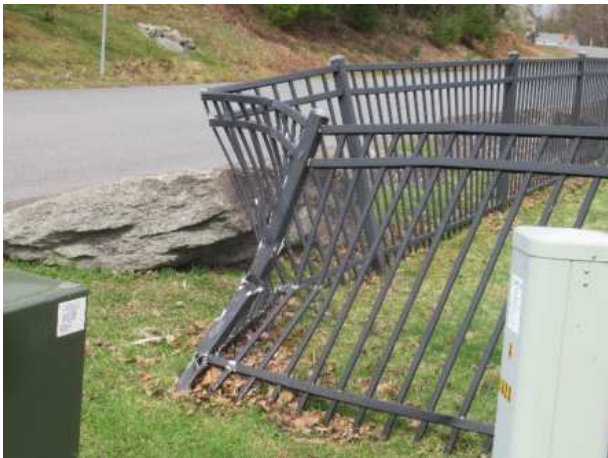
Condition: Fair overall condition; however we note damage to the fence from a vehicle collision. The board informs us repairs will take place in the near future funded outside of reserves.

Fence damage due to vehicle collision

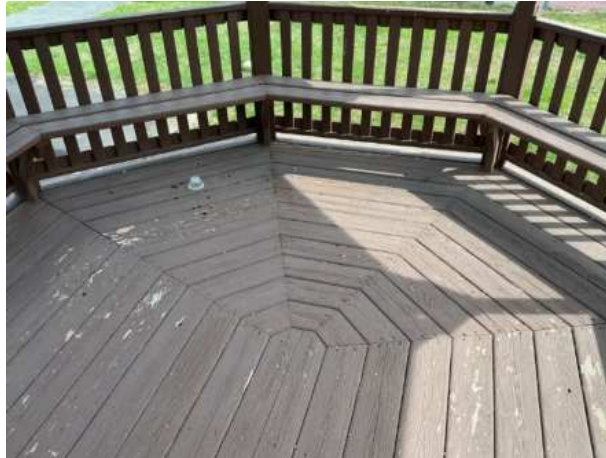
Condition: Fair overall condition with weathered wood and deterioration evident.

Wood deck boards – note deterioration

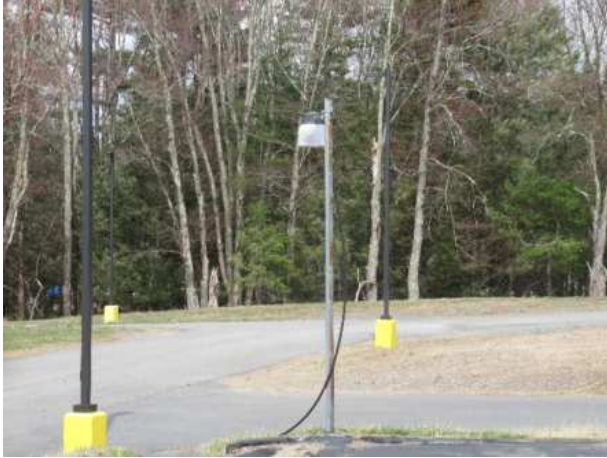
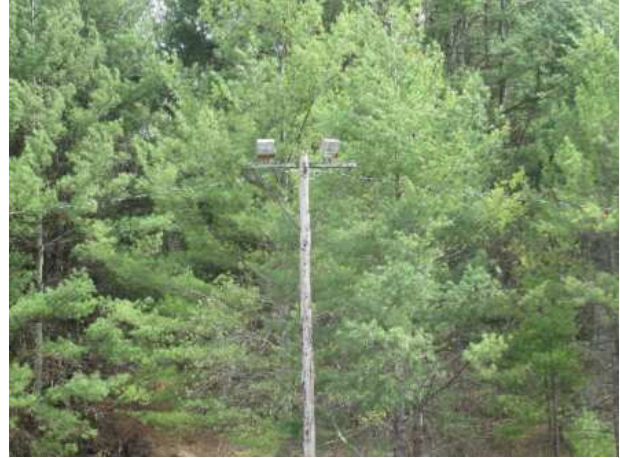
Light pole and fixture at the upper lot by the clubhouse

Condition: The light poles and fixtures at the pool house parking area and lower entrance drive are in good overall condition. The light poles and fixtures at the upper lot near the clubhouse are in fair to poor overall condition with leaning poles, dated fixtures and deterioration evident.

- As-needed:
 - Inspect and repair broken or dislodged fixtures, and leaning or damaged poles
 - Replaced burned out bulbs as needed

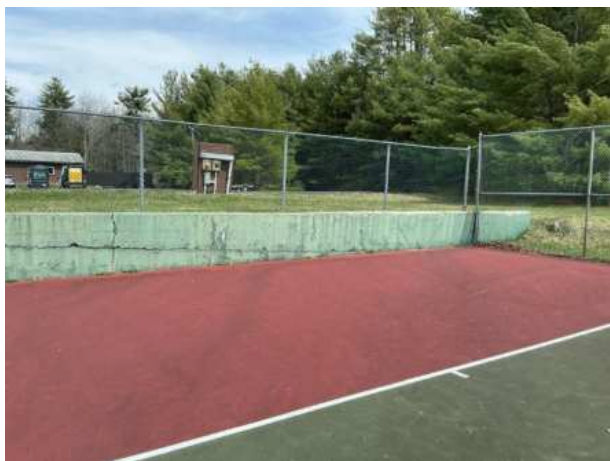
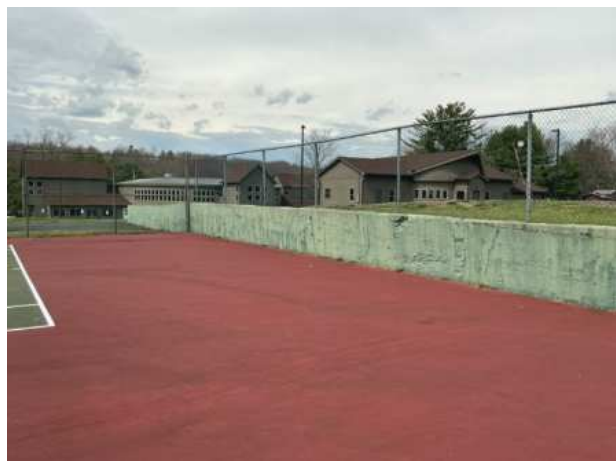
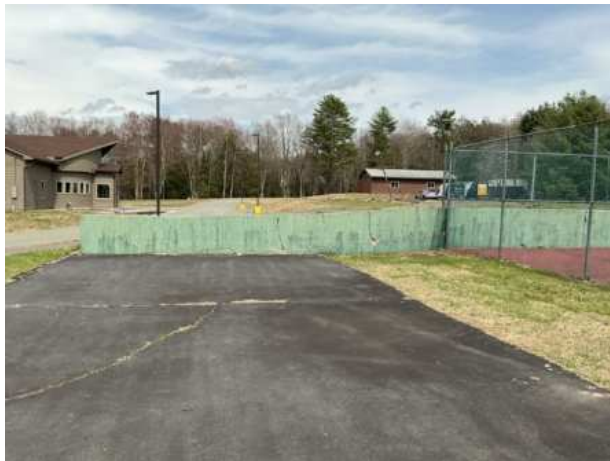
Condition: Fair to poor overall condition with extensive cracks, spalling, scaling, leaning sections and deterioration evident.

Concrete retaining wall

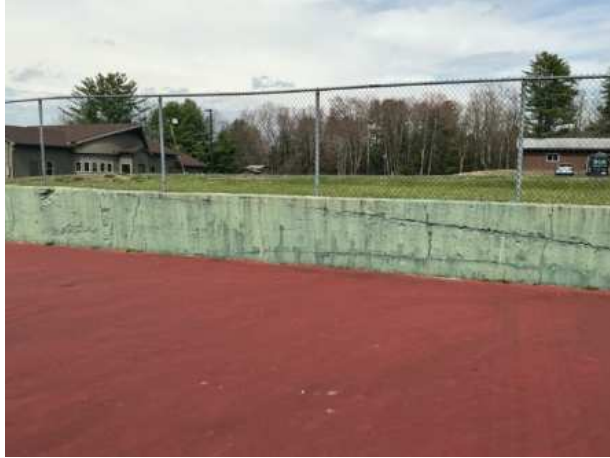
Cracks and deterioration

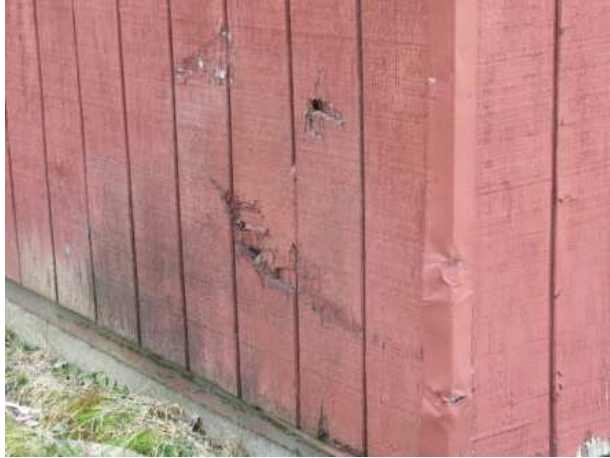
Condition: Fair to poor overall condition with damage, warps, paint finish deterioration and missing wood trim evident.

Wood damage and deterioration

Expenditure Detail Notes: Expenditure timing and costs are depicted in the **Reserve Expenditures** table in Section 3. We recommend the Association budget for paint applications and repairs through the operating budget.

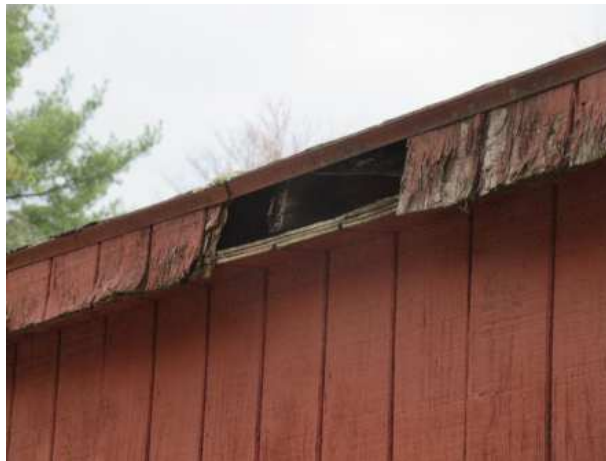
Missing wood trim

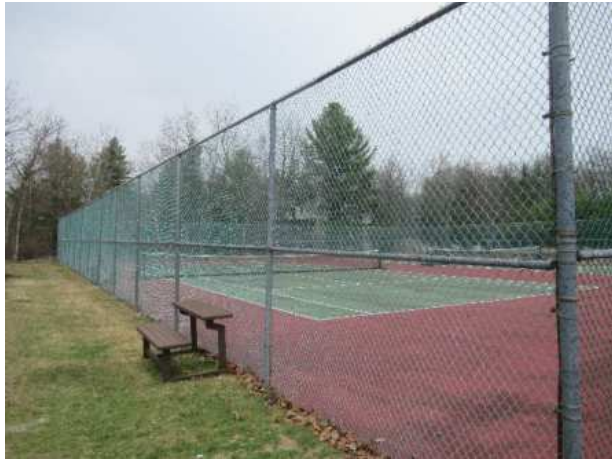
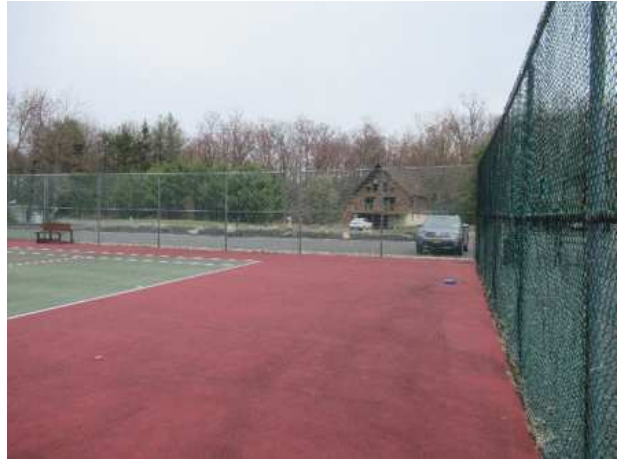
- **Tennis Court, Pool House:** 470 linear feet, unknown age, fair overall condition with rust, deterioration and warped webbing evident.

Tennis court fence at the pool house

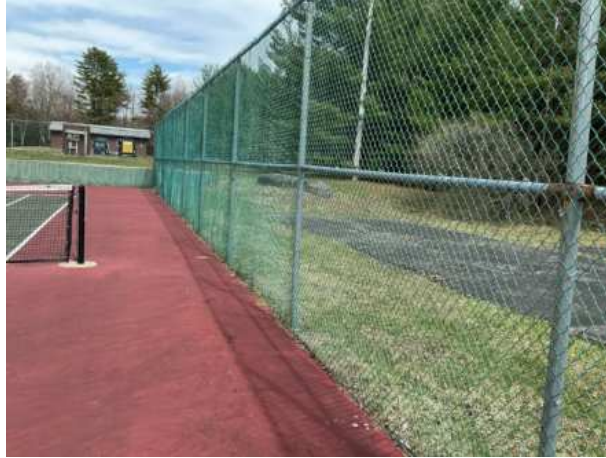
Tennis court fence at the clubhouse – note rust and warped webbing

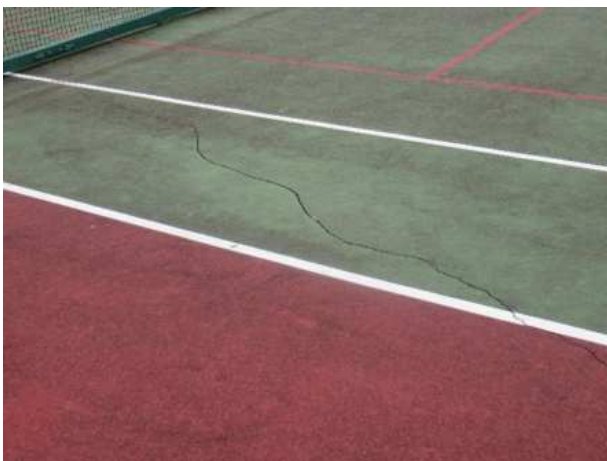
- **Tennis Courts, Pool House:** 13,540 square feet of asphalt comprising two tennis courts, the surface was replaced in 2021 and no color coat application has been completed since resurfacing, good to fair overall condition with cracks, color coat deterioration and stains evident.

Cracks at the tennis court at the pool house

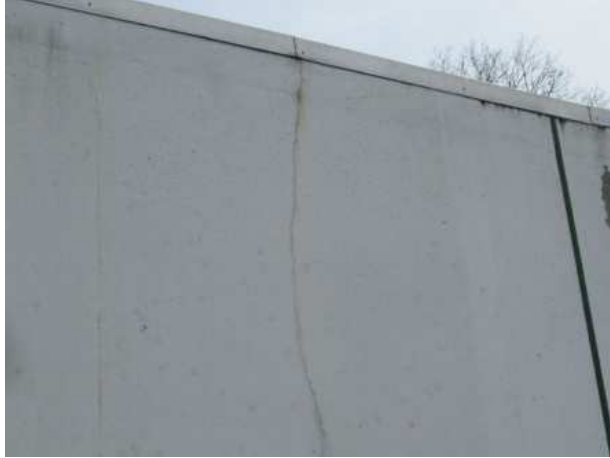
Condition: Fair overall condition with crack, finish deterioration, stains and leaning sections evident.

Cracks and finish deterioration

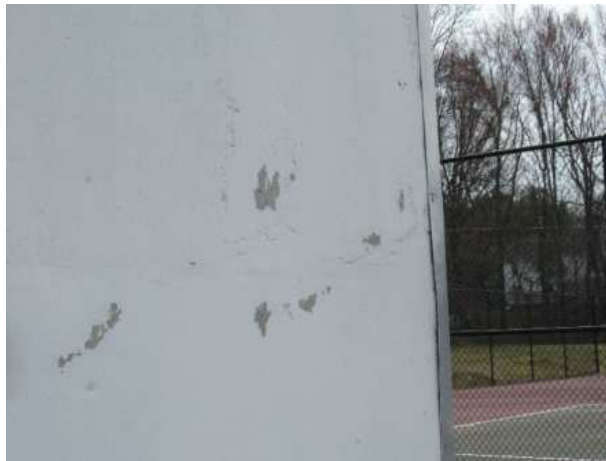
Cracks and finish deterioration

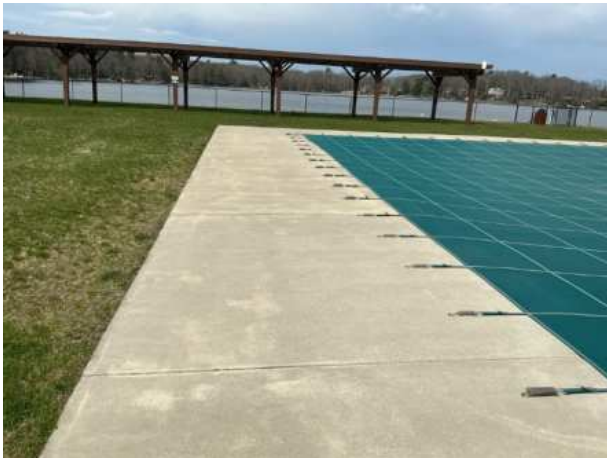
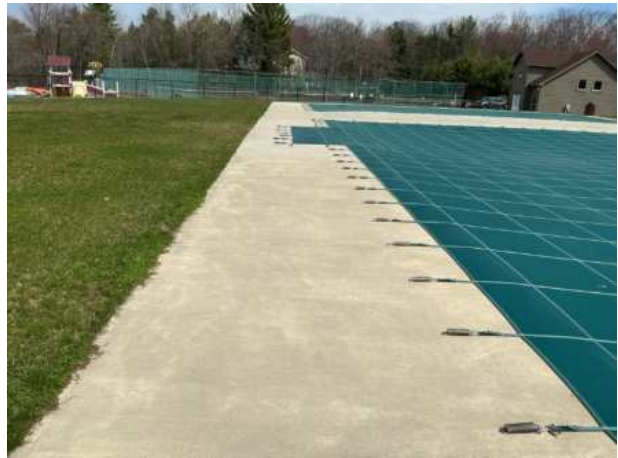
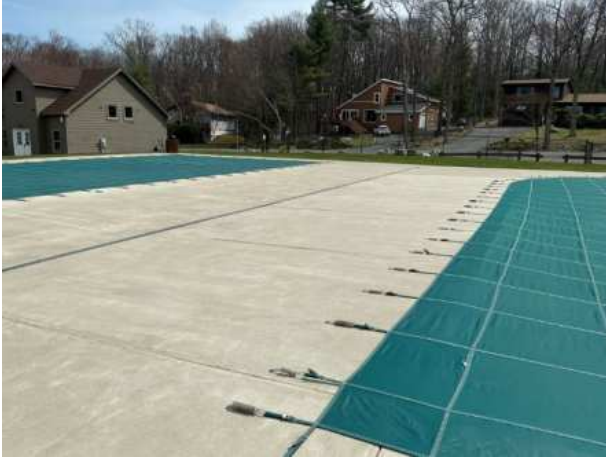
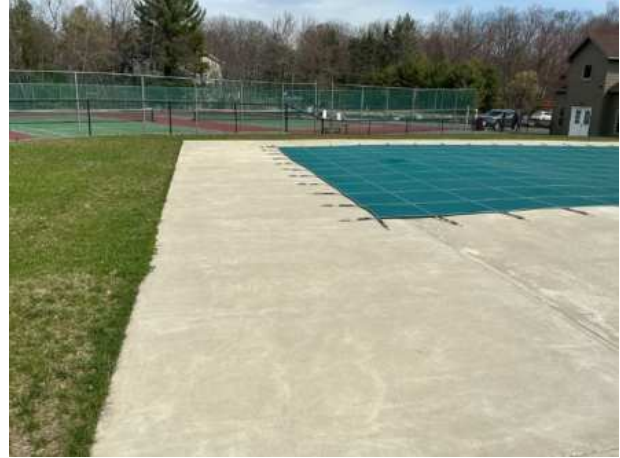
Condition: Good to fair overall condition with isolated cracks evident.

- Selective cut out and replacements of up to of concrete
- Crack repairs as needed
- Mortar joint repairs
- Caulk replacement

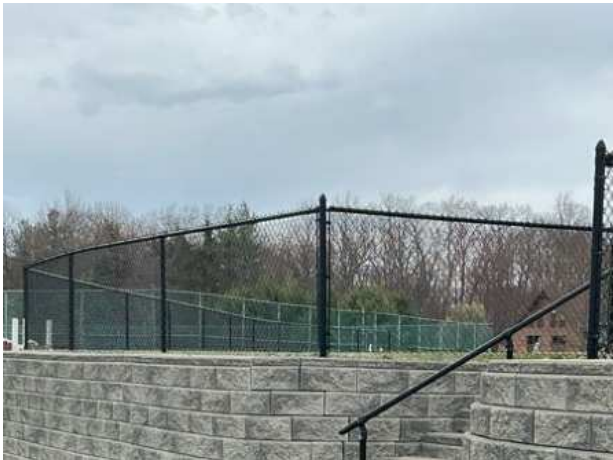
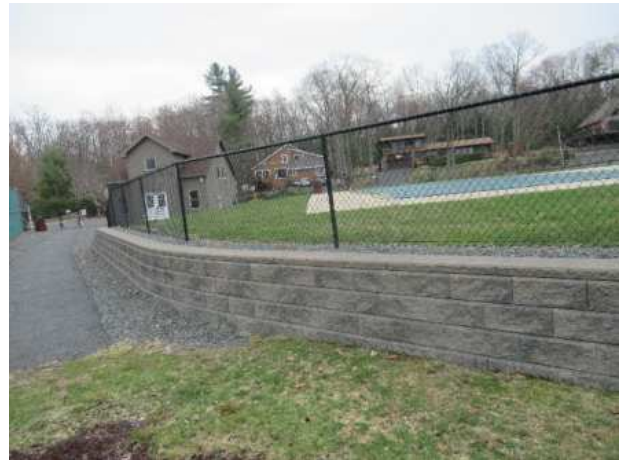
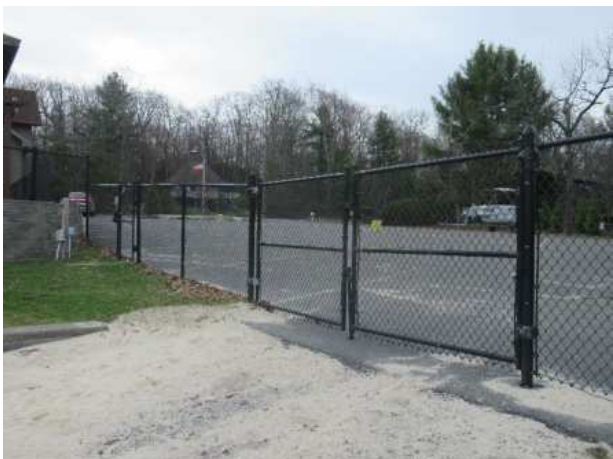
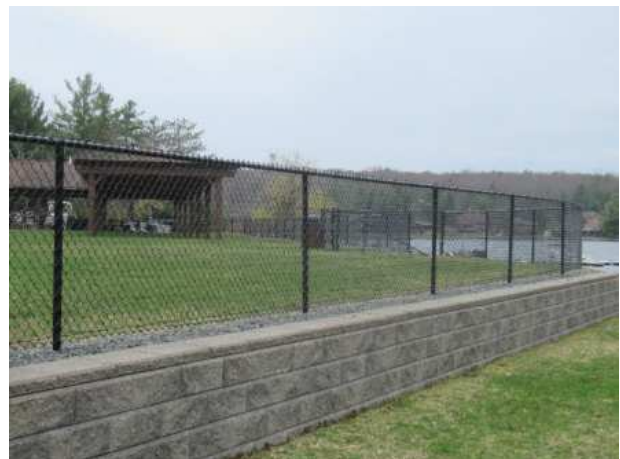
Condition: Good overall condition

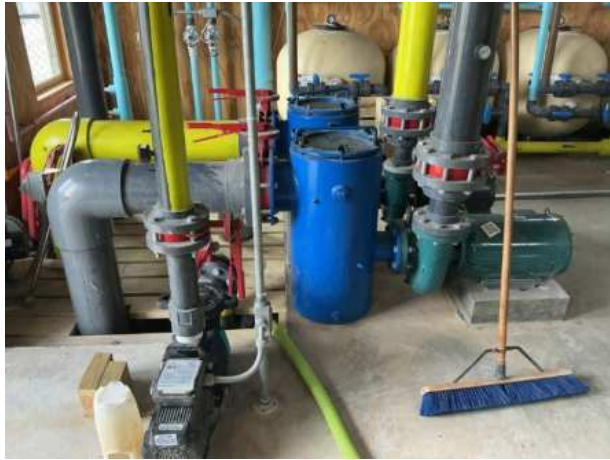
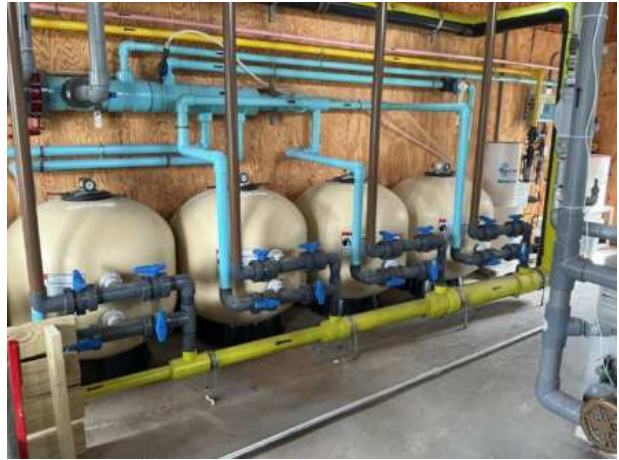
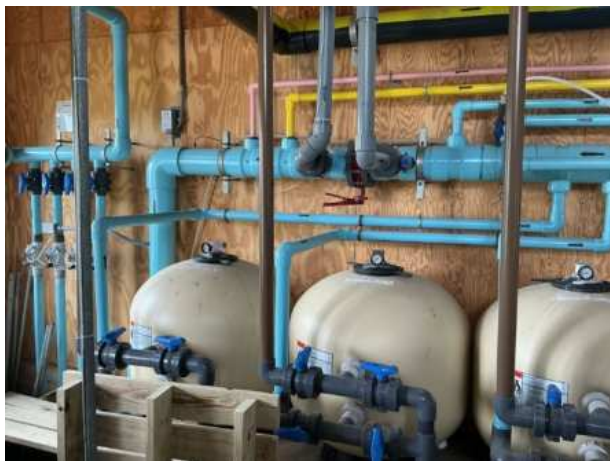
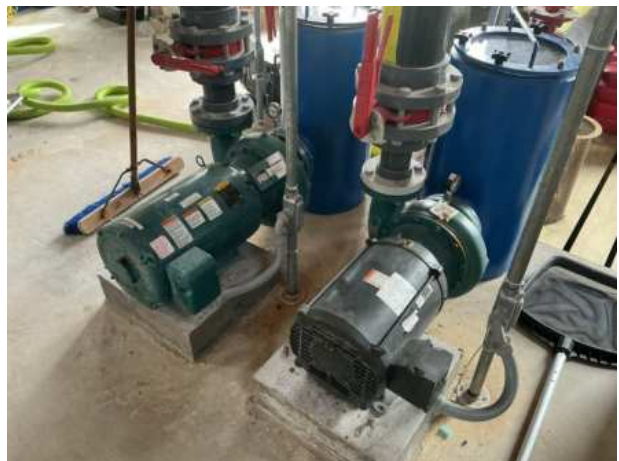
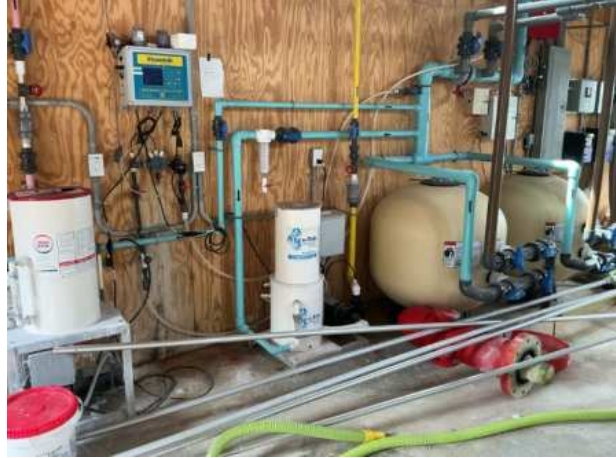
Condition: Reported satisfactory without operational deficiencies. Management informs us of minor repairs since installation.

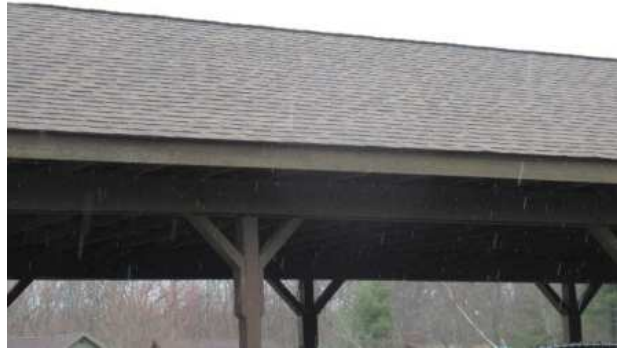
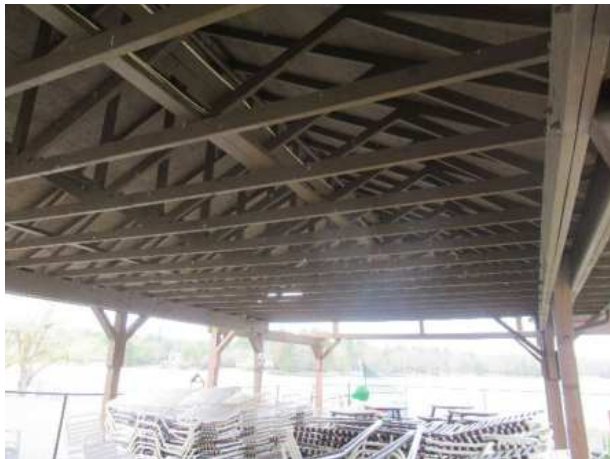
Condition: Fair overall condition with missing shingles, stains deterioration at the asphalt shingle roof and weathered wood and paint finish deterioration at the wood structure.

Expenditure Detail Notes: Expenditure timing and costs are depicted in the **Reserve Expenditures** table in Section 3. We recommend the Association budget for paint applications and repairs through the operating budget.

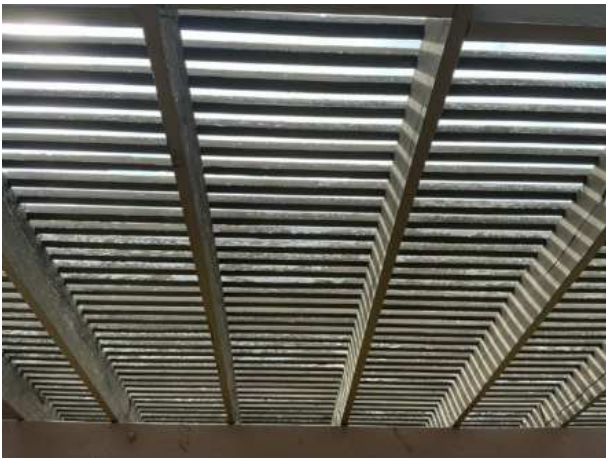
Condition: Fair overall condition with paint finish deterioration and weathered wood.

Paint finish deterioration

Expenditure Detail Notes: Expenditure timing and costs are depicted in the **Reserve Expenditures** table in Section 3. We recommend the Association budget for paint applications and repairs through the operating budget.
