Emerald Green Property Owners Association

April 13, 2026 • Rock Hill, NY

FULL RESERVE STUDY

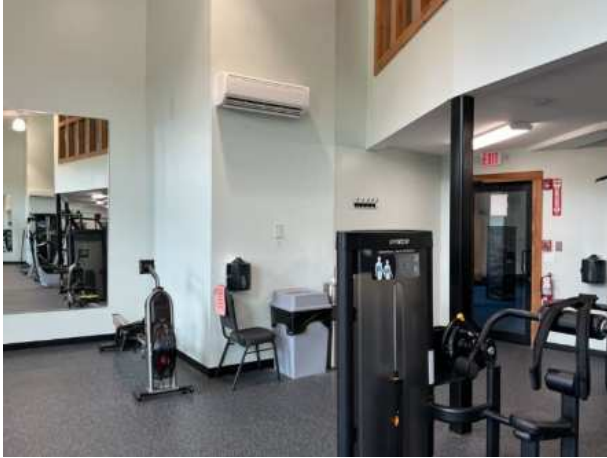
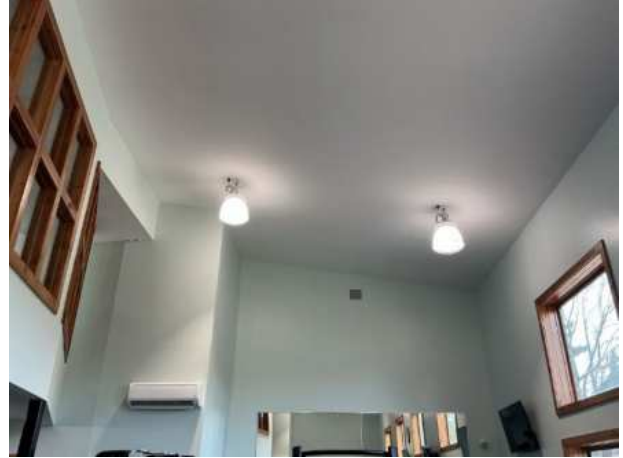
Condition: Good overall condition with no significant deterioration

Exercise room overview

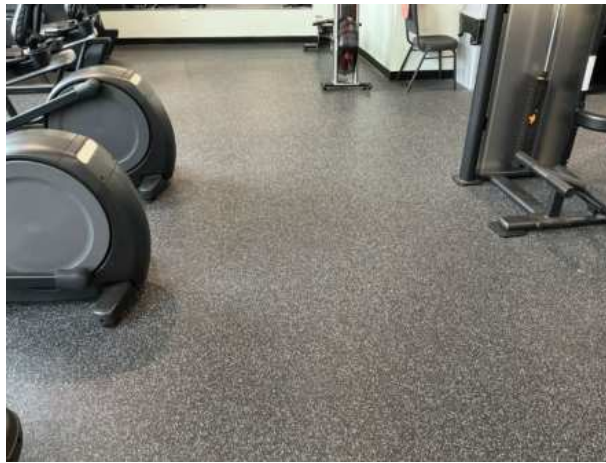
Rubber floor coverings

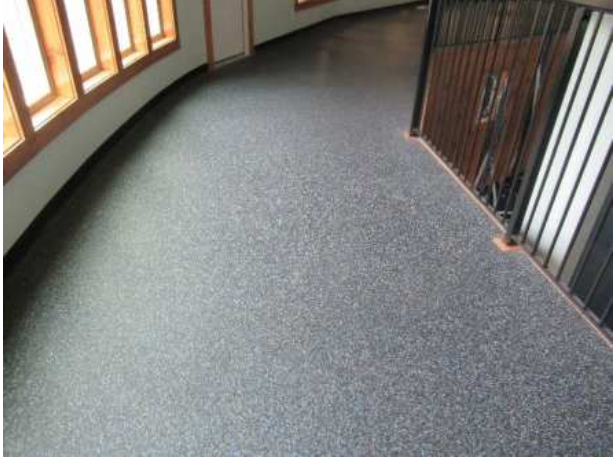
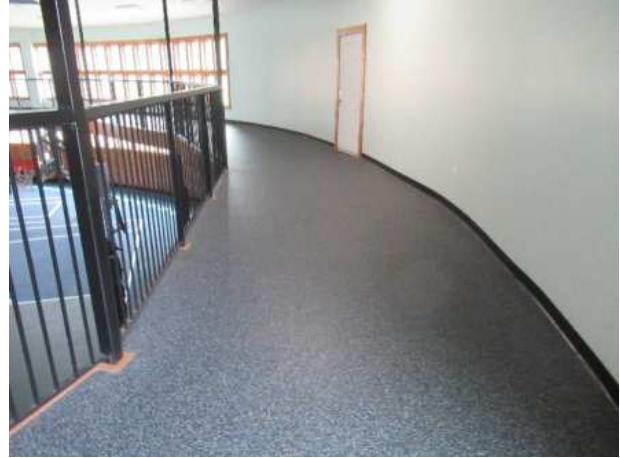
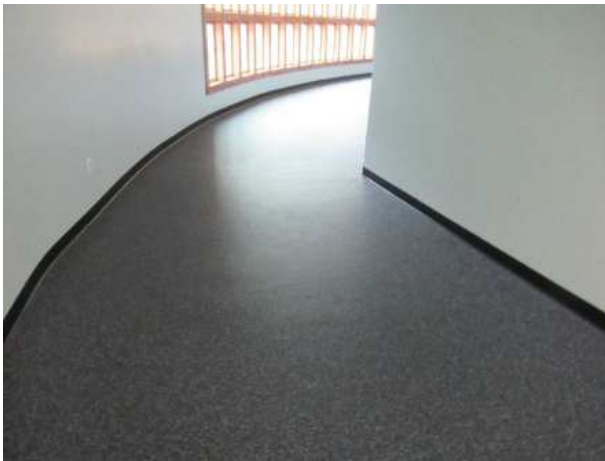
Condition: Good to fair overall condition with minor wear evident

Rubber track

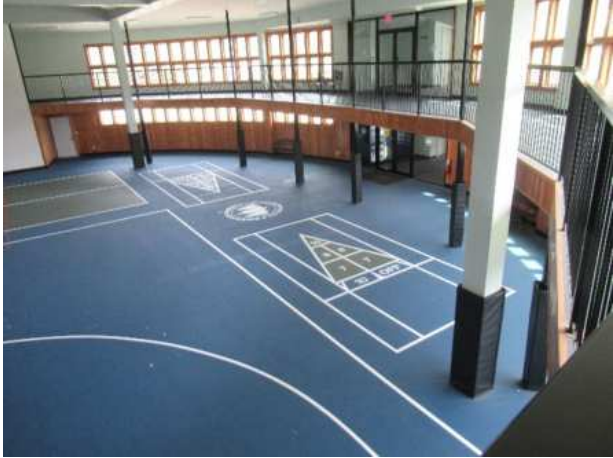
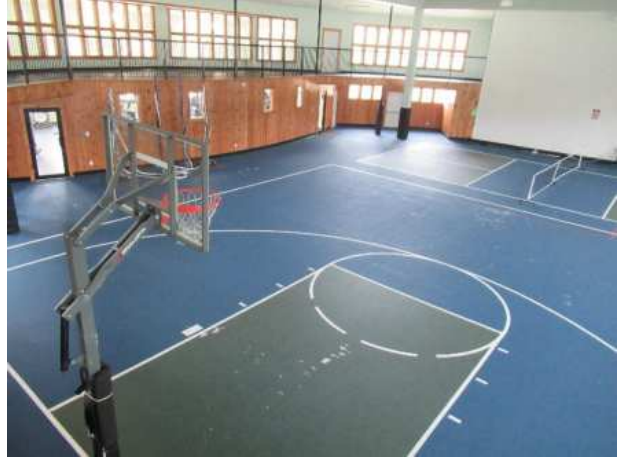
Condition: Good to fair overall condition with scuffs, damage and deterioration evident.

Sports court overview

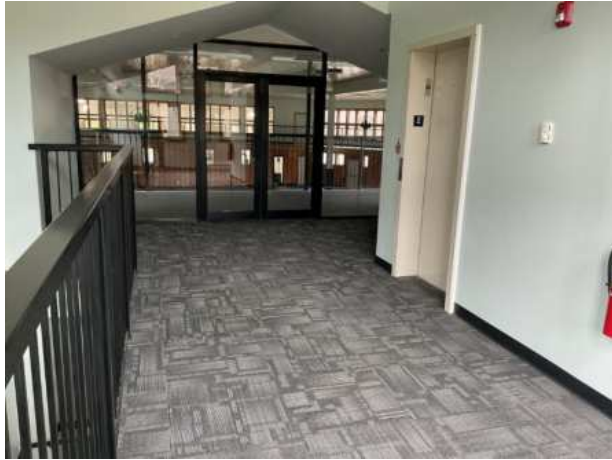
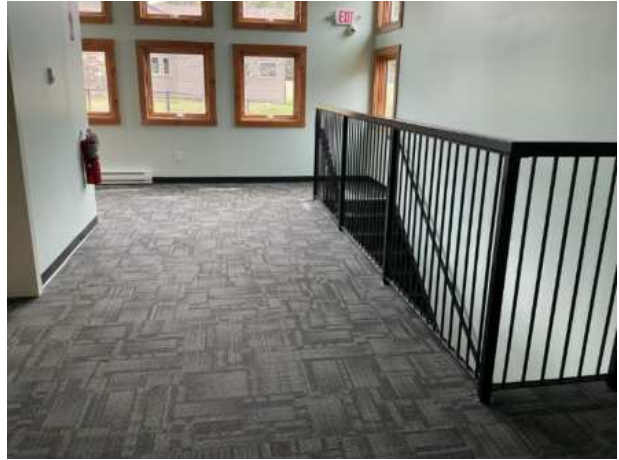
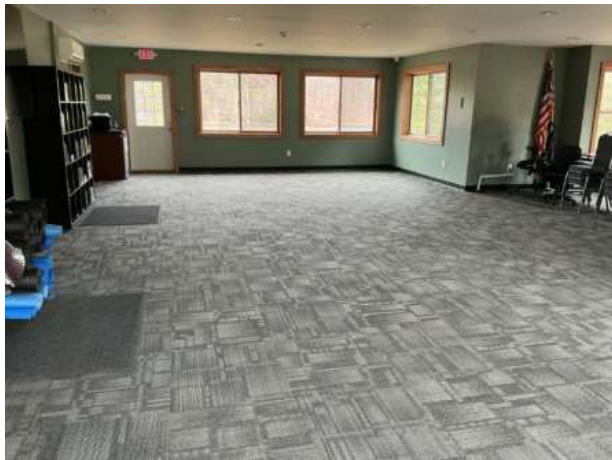
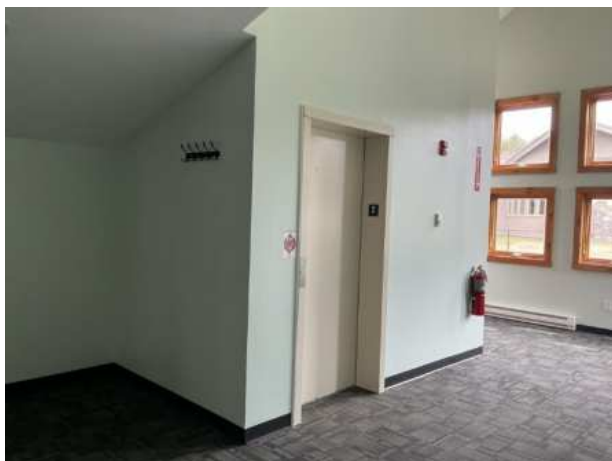
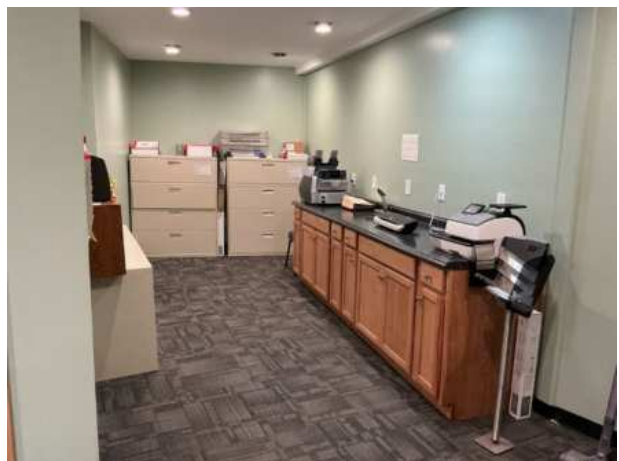
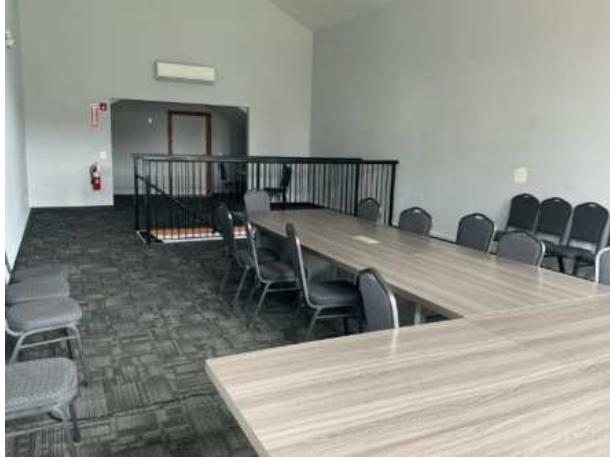
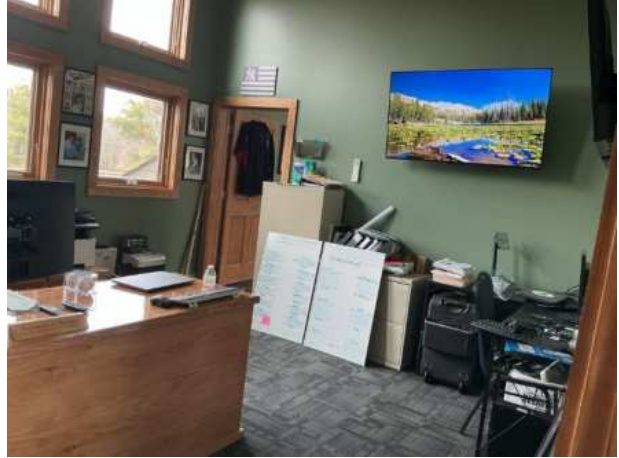
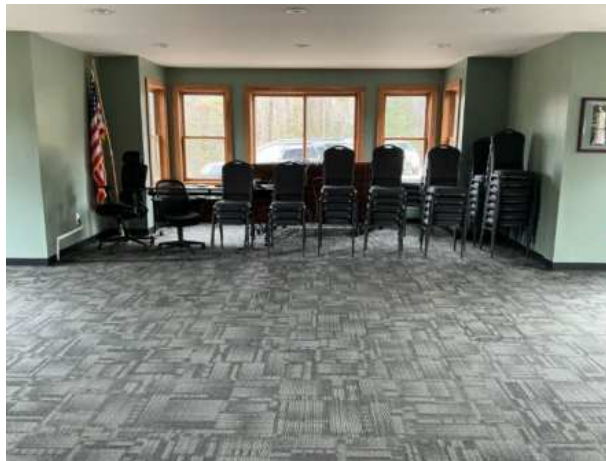
Condition: Good overall condition with no significant deterioration

Expenditure Detail Notes: Expenditure timing and costs are depicted in the **Reserve Expenditures** table in Section 3. The complete renovation should include replacement of all components listed above and the partial renovations should include the following:

- Replacement of the carpet
- Paint finish application
- Replacement of up to fifty percent (50%) of the furnishings

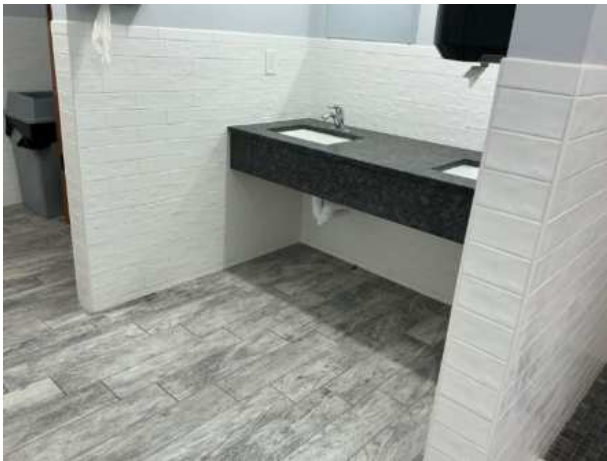
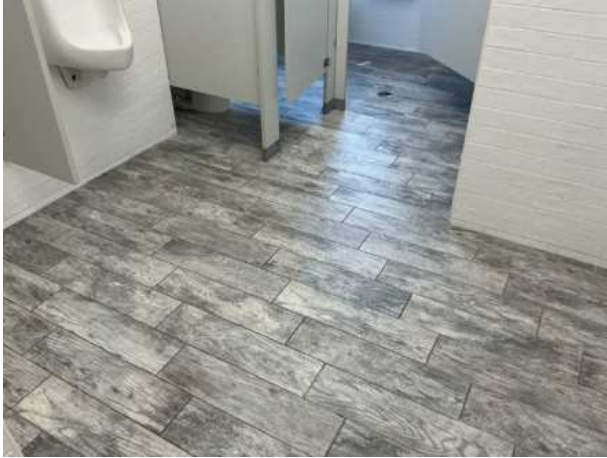
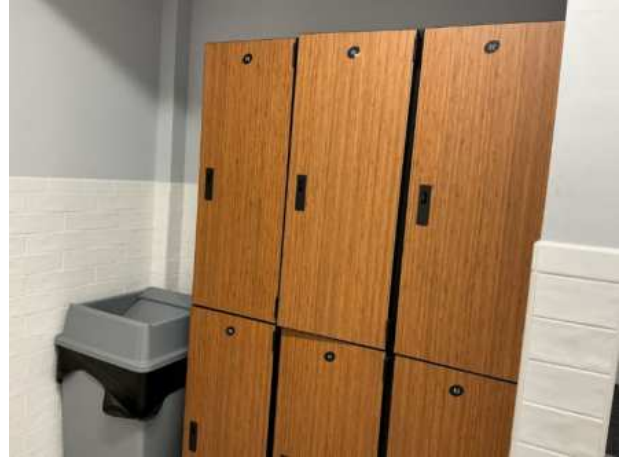
Condition: Good overall condition with no significant deterioration

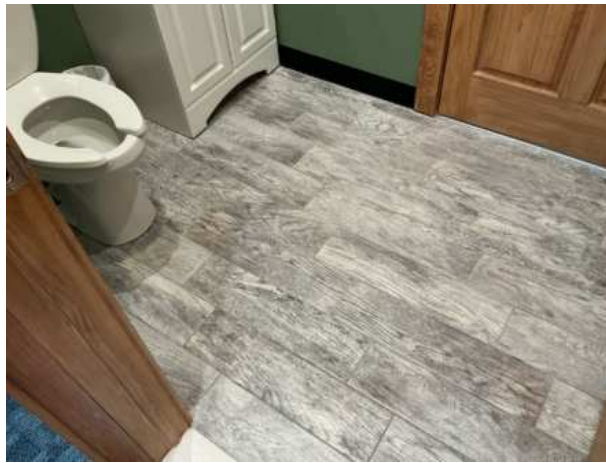
Condition: Good overall condition with no significant deterioration.

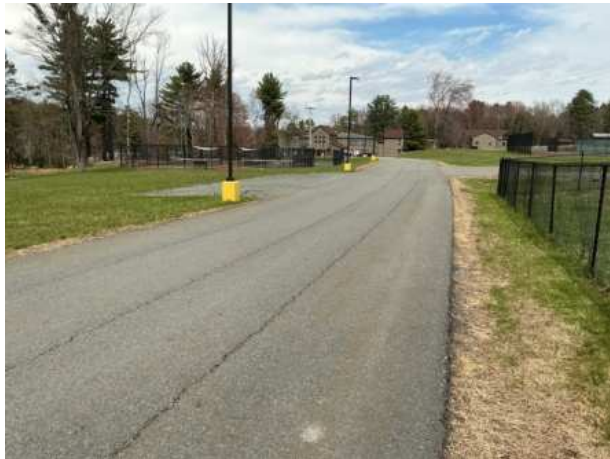
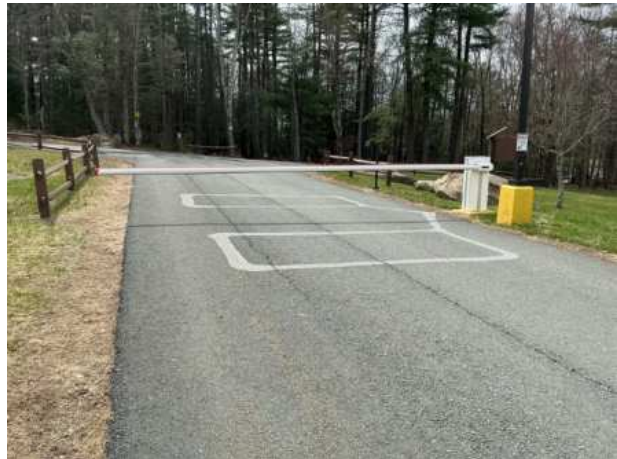
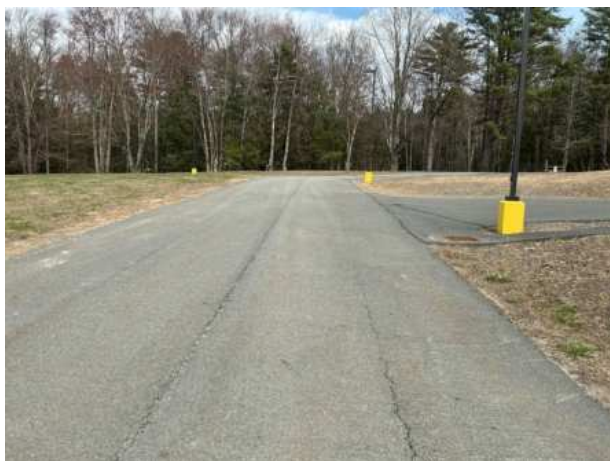
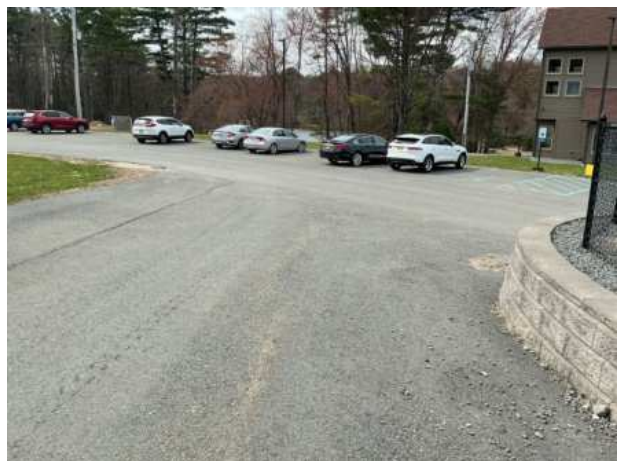
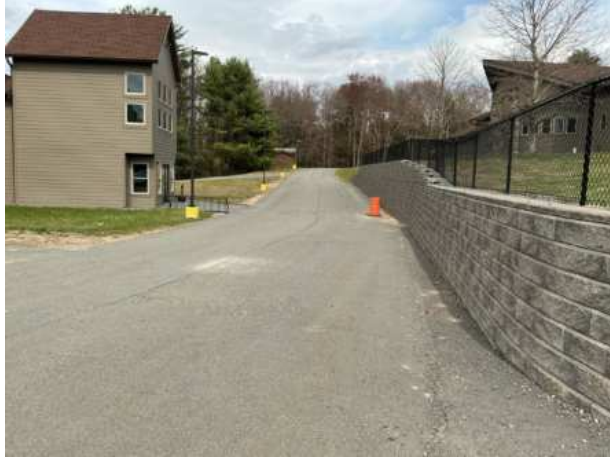
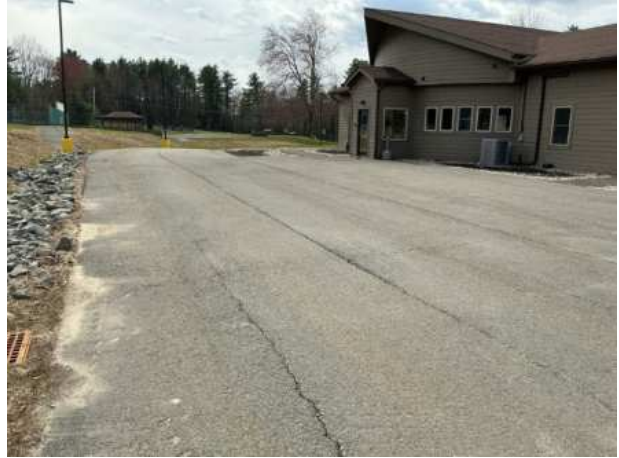
Condition: Fair overall condition with cracks observed and no asphalt wear course installed at the time of inspection. The Association informs of plans to install the final wear course in 2026.

Component Detail Notes: Proposals should include mechanically routing and filling all cracks with hot emulsion. Repairs should also include patching at areas exhibiting settlement, potholes, or excessive cracking.

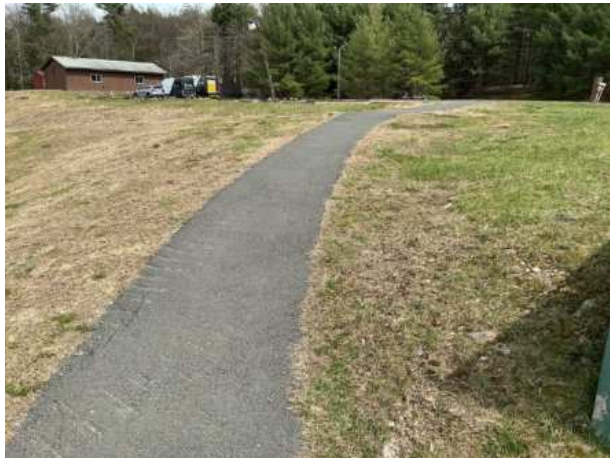
Cracks

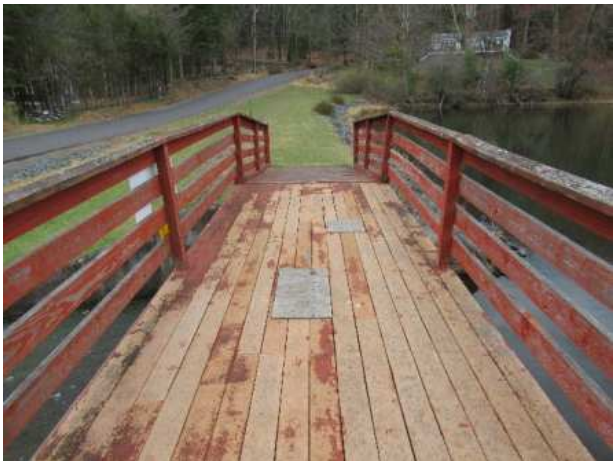
Condition: Poor overall condition with weathered wood, finish deterioration, rust at the metal framing, partial repairs and warps evident.

Wood decking

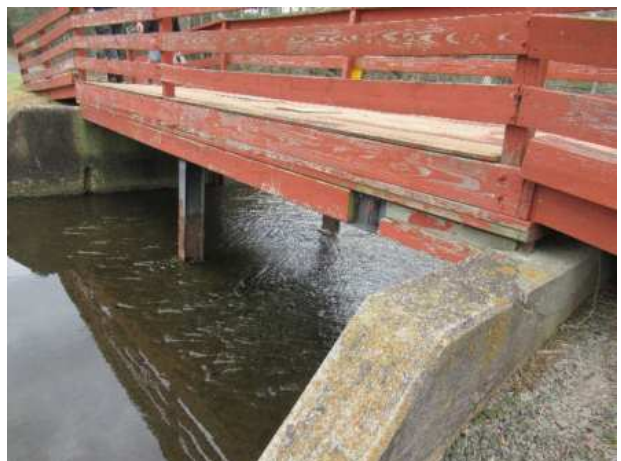
Bridge structure

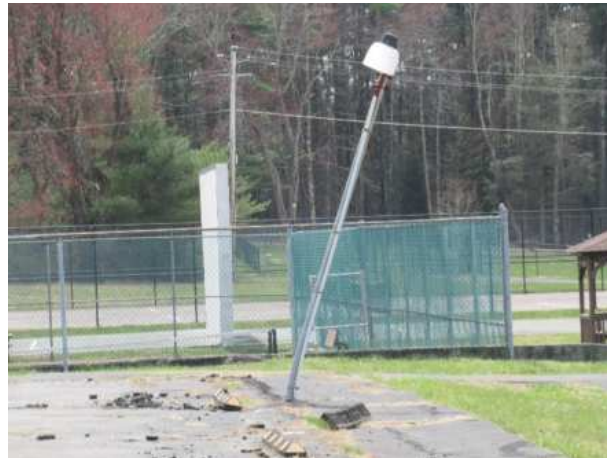
Condition: The light poles and fixtures at the pool house parking area and lower entrance drive are in good overall condition. The light poles and fixtures at the upper lot near the clubhouse are in fair to poor overall condition with leaning poles, dated fixtures and deterioration evident.

Leaning pole

- As-needed:
 - Inspect and repair broken or dislodged fixtures, and leaning or damaged poles
 - Replaced burned out bulbs as needed

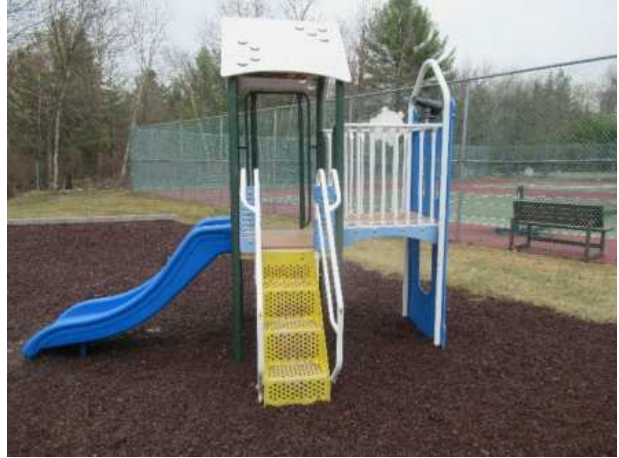
Playground near pool house

Condition: The playground at the pool house is in good overall condition and the playground near the clubhouse is in fair overall condition with rusted chains, weathered wood and deterioration evident.

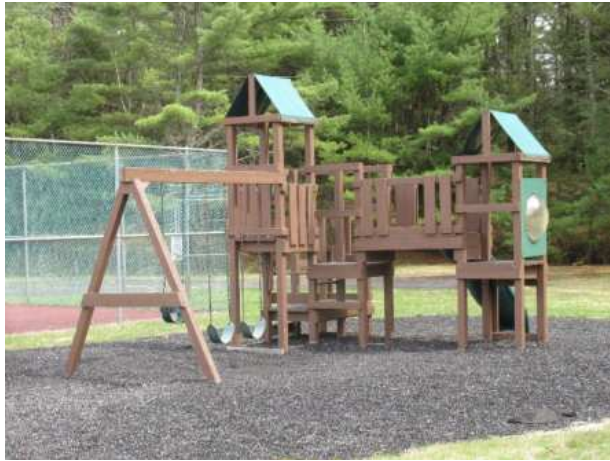
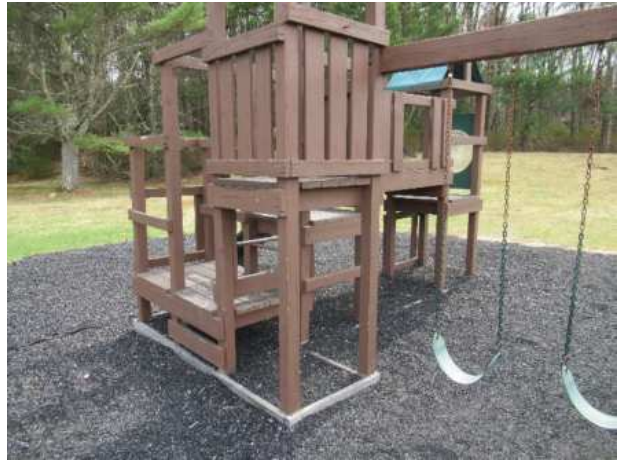
Playground near clubhouse

Component Detail Notes: Safety is the major purpose for maintaining playground equipment. We recommend an annual inspection of the playground equipment to identify and repair as normal maintenance loose connections and fasteners or damaged

- Annually:
 - Inspect and repair loose connections and fasteners or damaged elements
 - Inspect for safety hazards and adequate coverage of ground surface cover

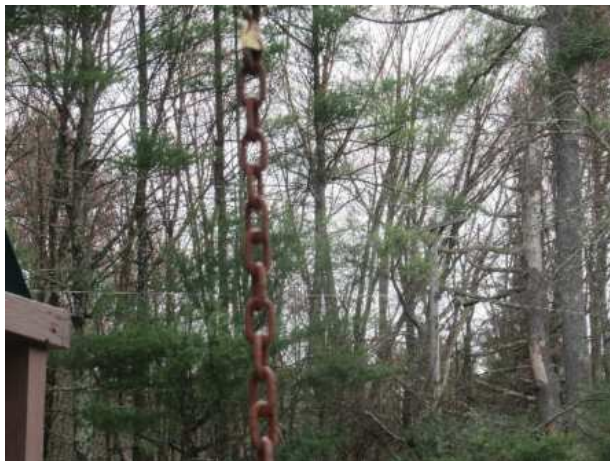
Rusted chain

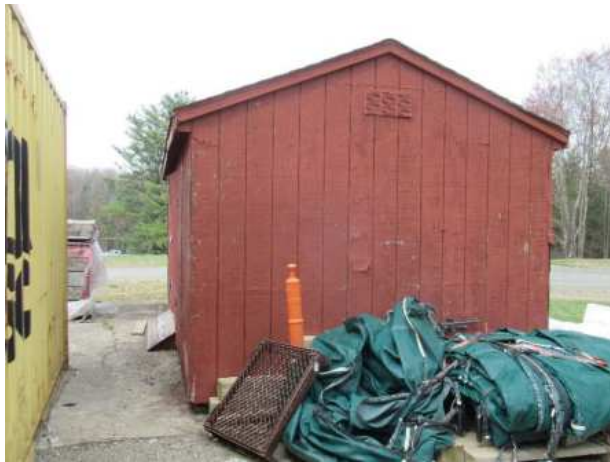
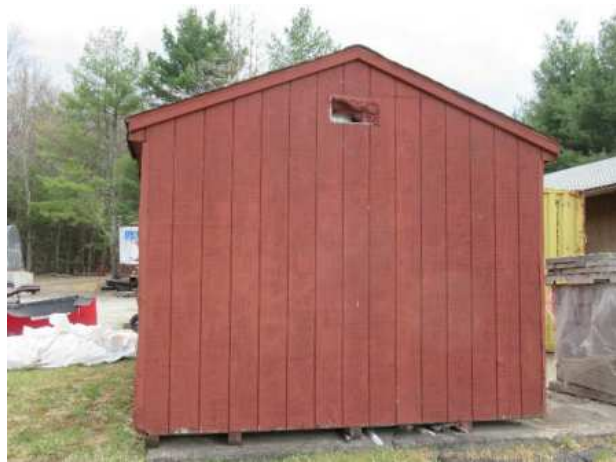
Condition: Fair to poor overall condition with damage, warps, paint finish deterioration and missing wood trim evident.

Shed overview

Expenditure Detail Notes: Expenditure timing and costs are depicted in the **Reserve Expenditures** table in Section 3. We recommend the Association budget for paint applications and repairs through the operating budget.

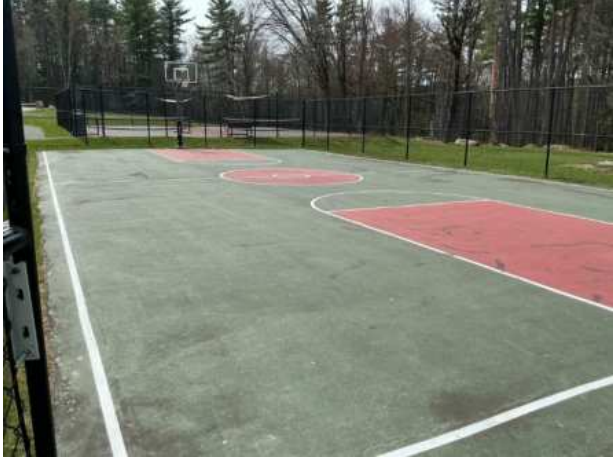
- **Basketball Court:** 2,960 square feet of asphalt comprising one basketball courts, the surface was replaced in 2021 and no color coat application has been completed since resurfacing, good to fair overall condition with cracks, patches, color coat deterioration and stains evident.

Basketball court overview

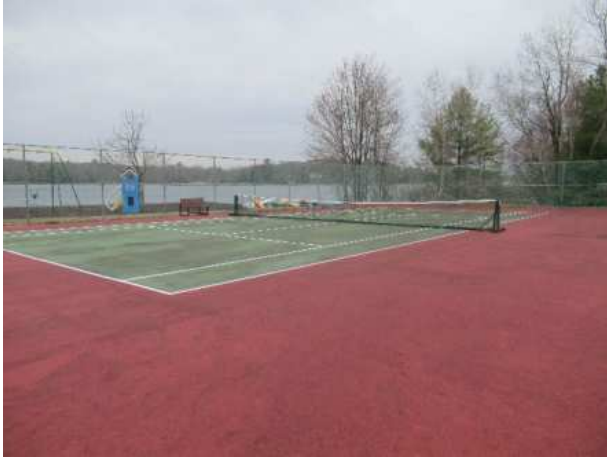
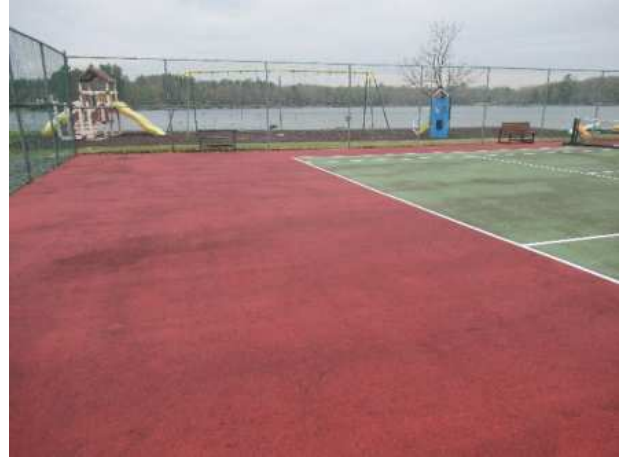
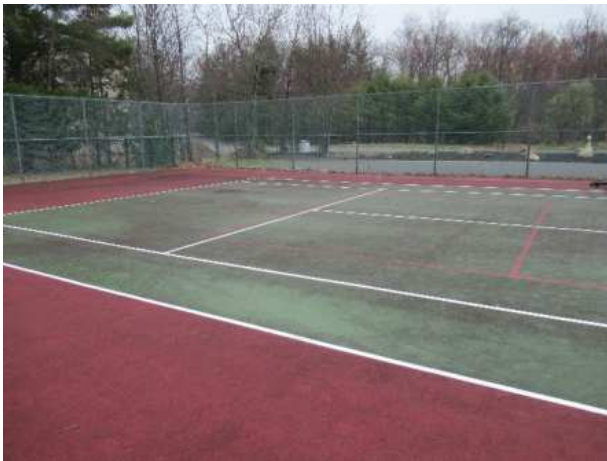
- **Tennis Courts, Pool House:** 13,540 square feet of asphalt comprising two tennis courts, the surface was replaced in 2021 and no color coat application has been completed since resurfacing, good to fair overall condition with cracks, color coat deterioration and stains evident.

Tennis court overview at the pool house

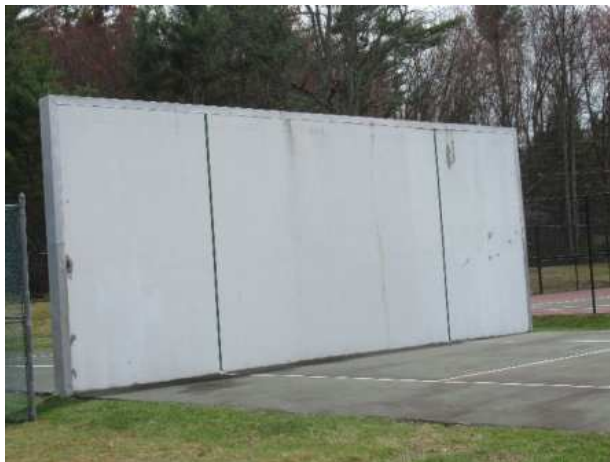
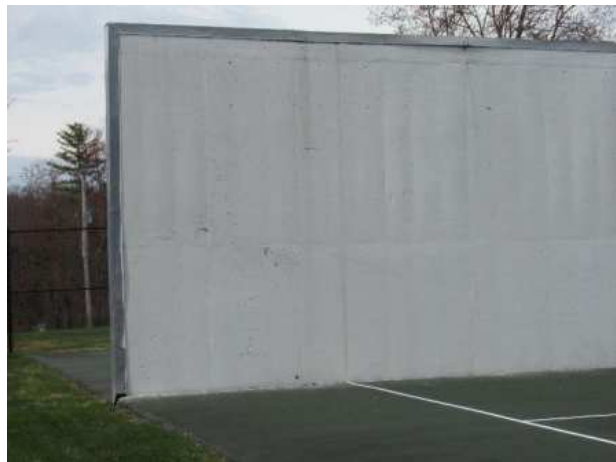
Condition: Fair overall condition with crack, finish deterioration, stains and leaning sections evident.

Raquetball / handball wall

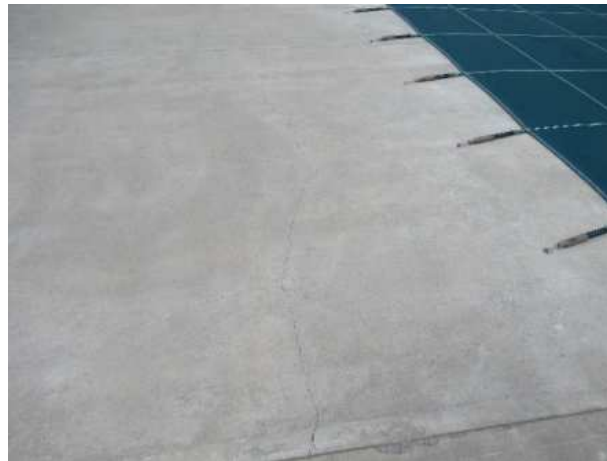
Condition: Good to fair overall condition with isolated cracks evident.

Cracks

- Selective cut out and replacements of up to of concrete
- Crack repairs as needed
- Mortar joint repairs
- Caulk replacement

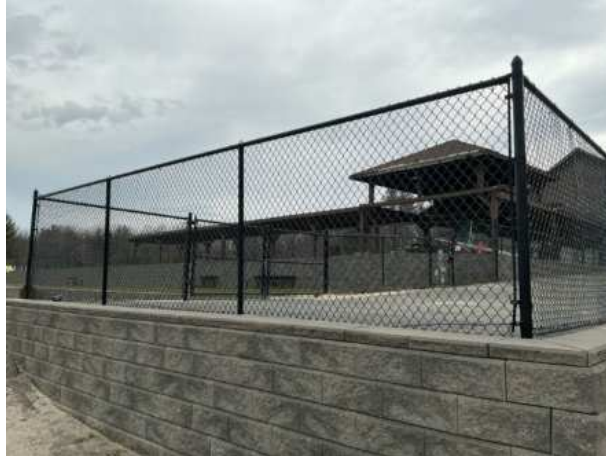
Condition: Good overall condition

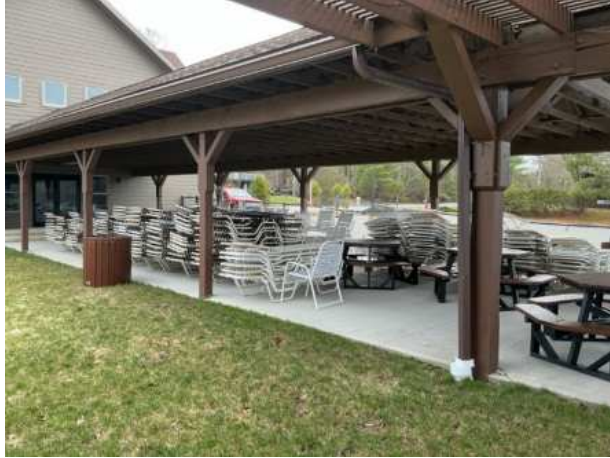
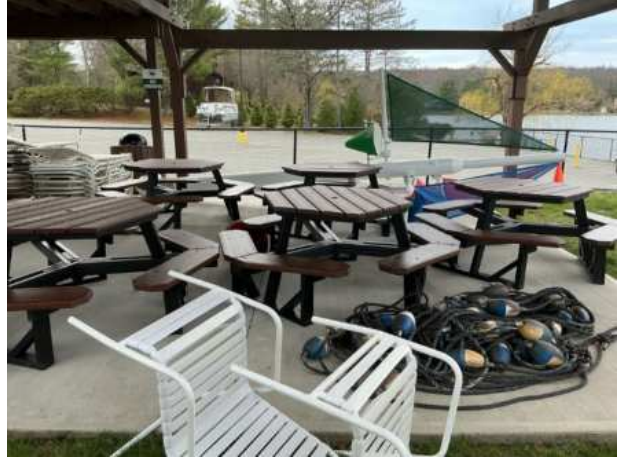
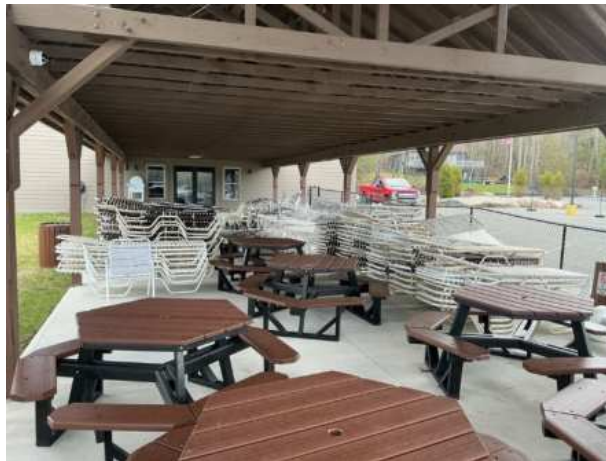
Condition: Good overall condition with no significant deterioration.

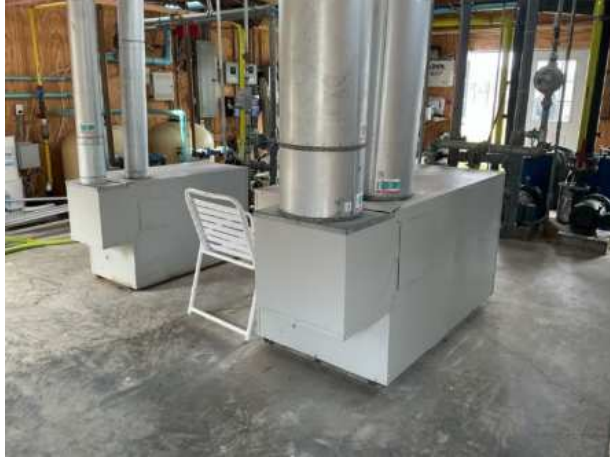
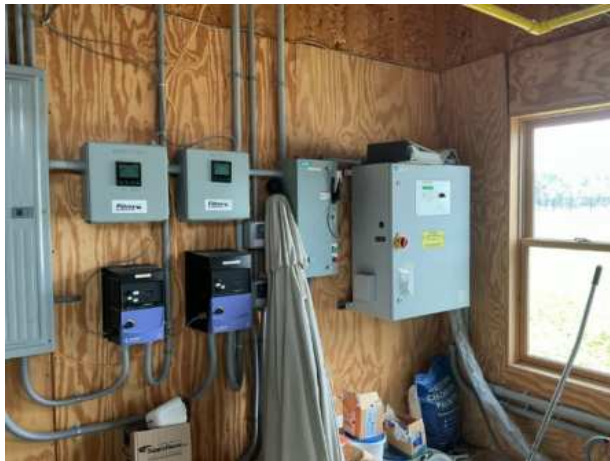
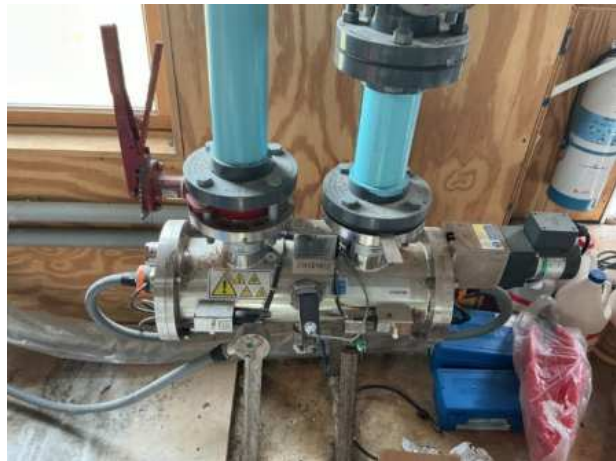
Condition: Reported satisfactory without operational deficiencies. Management informs us of minor repairs since installation.

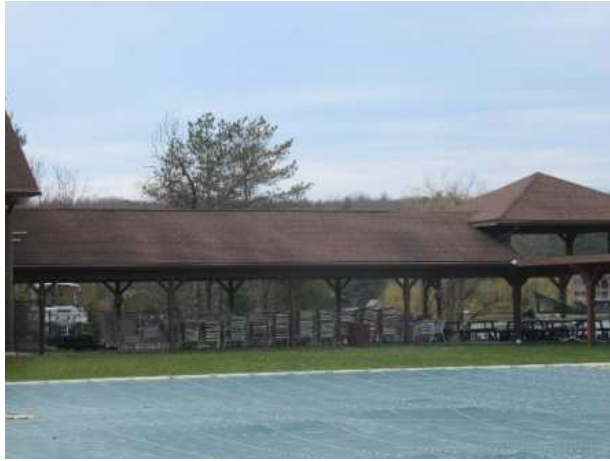
Condition: Fair overall condition with missing shingles, stains deterioration at the asphalt shingle roof and weathered wood and paint finish deterioration at the wood structure.

Expenditure Detail Notes: Expenditure timing and costs are depicted in the **Reserve Expenditures** table in Section 3. We recommend the Association budget for paint applications and repairs through the operating budget.

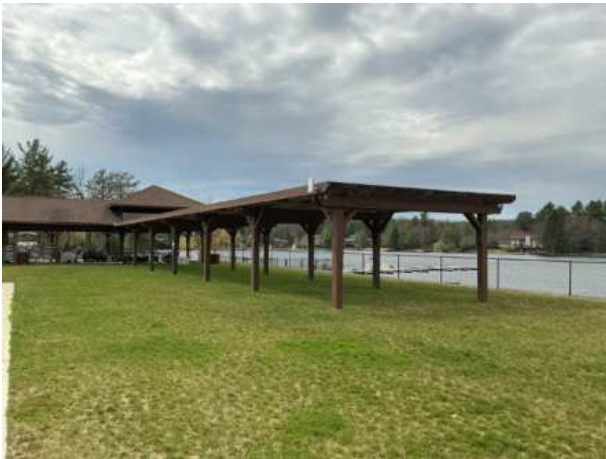
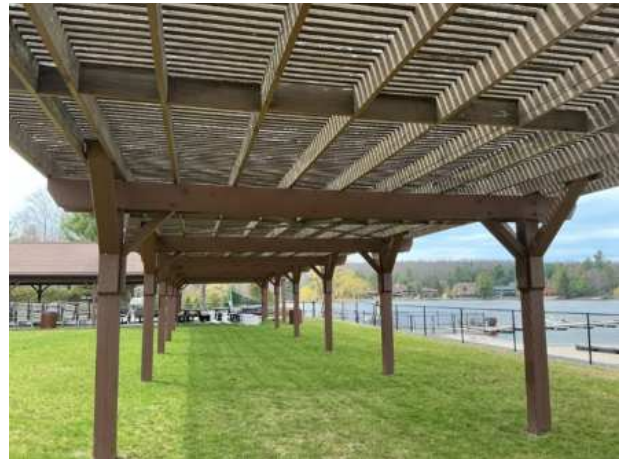
Condition: Fair overall condition with paint finish deterioration and weathered wood.

Expenditure Detail Notes: Expenditure timing and costs are depicted in the **Reserve Expenditures** table in Section 3. We recommend the Association budget for paint applications and repairs through the operating budget.

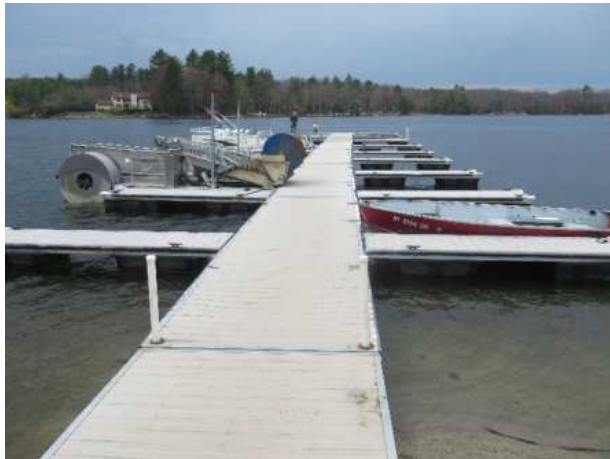
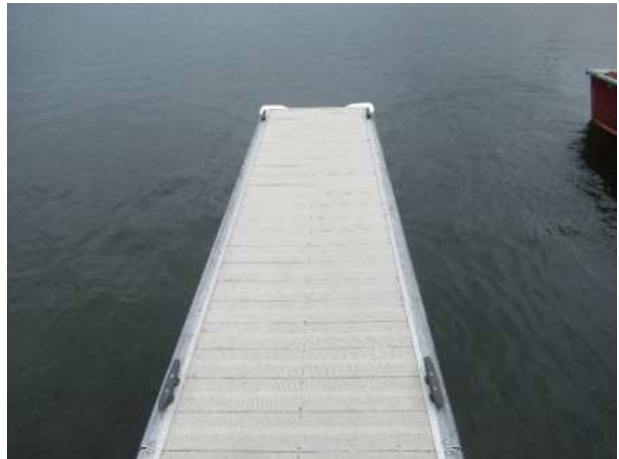
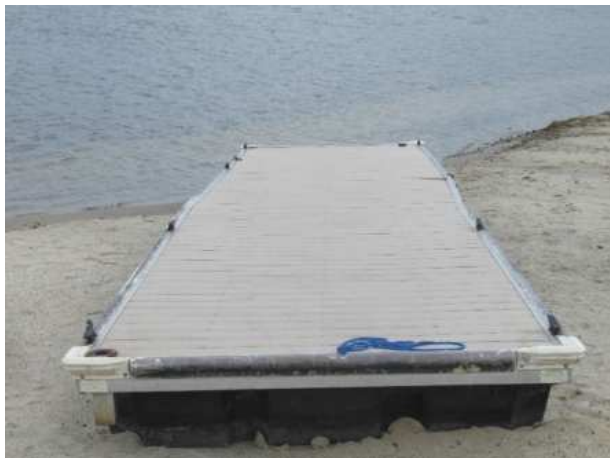
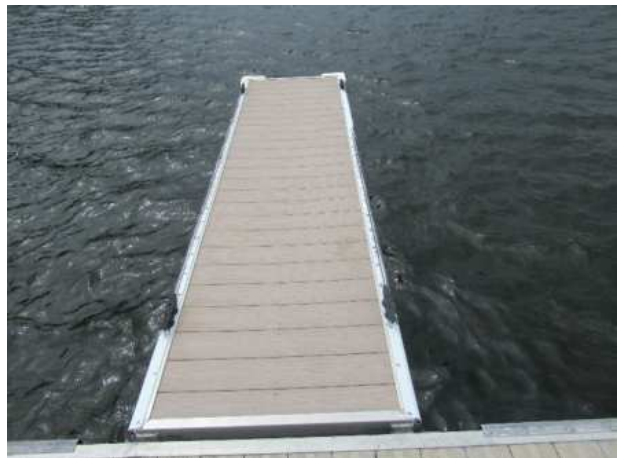
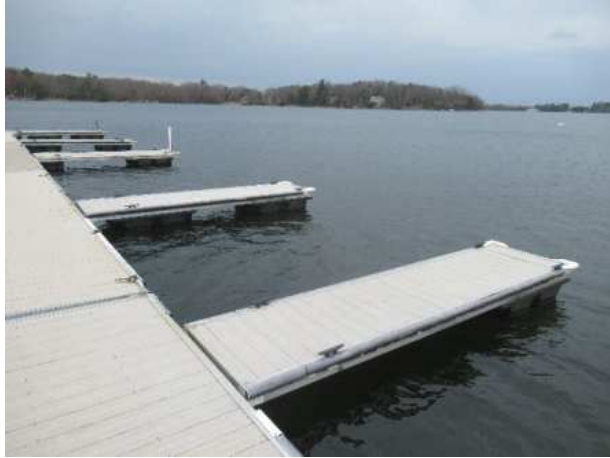
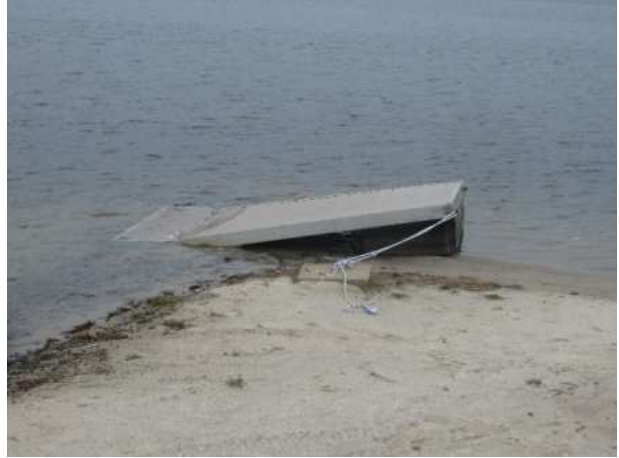
Condition: Good to fair overall condition with minor stains and partial replacements evident.

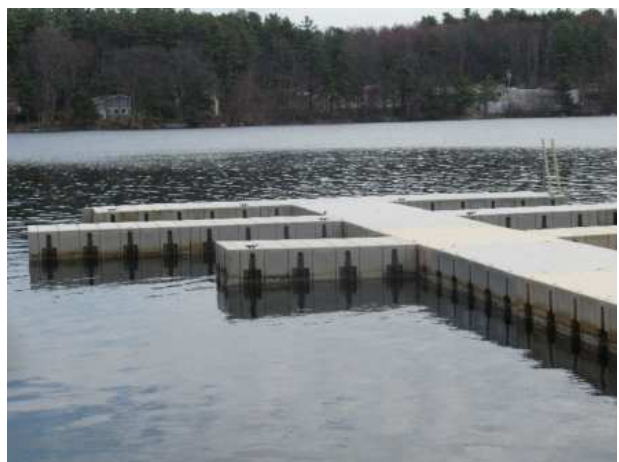
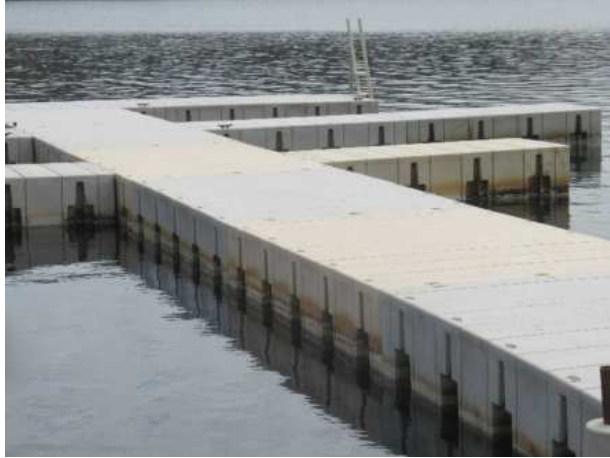
Condition: Good to fair overall condition with stains and color fade evident

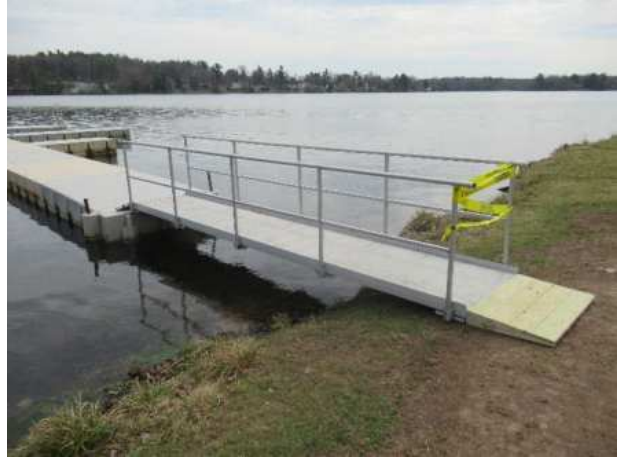
Floating PVC dock overview
